## **BUILDING SURVEYORS REPORT**

### **Weathertightness Risk and Building Condition Assessment**

516 Frankton Ladies Mile Highway

26 March 2019

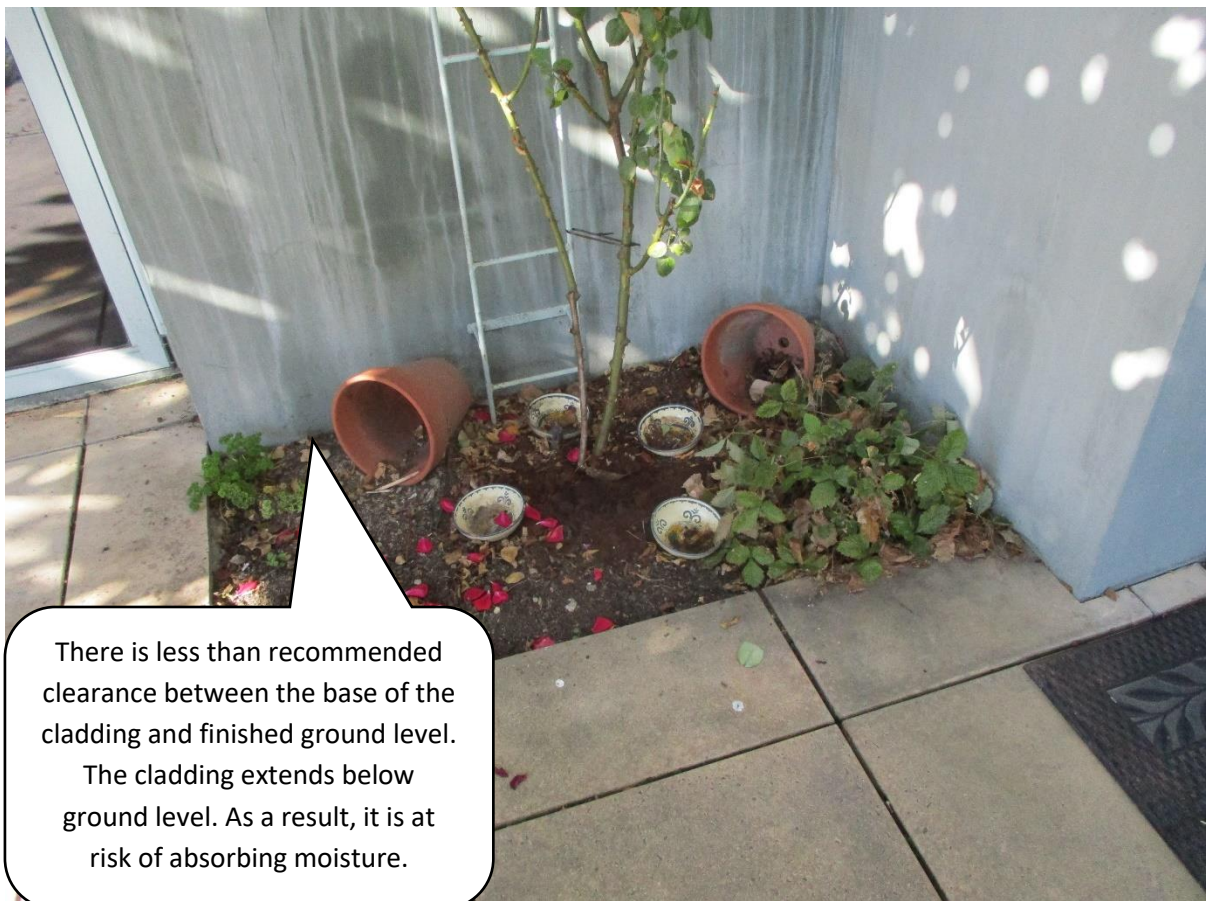
6.

There is less than recommended clearance between the base of the cladding and finished ground level on all elevations. The plaster cladding currently extends below finished ground level. No method to waterproof the plaster was observed. Uncoated plaster including bottom edges are very absorbent, and they will wick water from adjacent surfaces such as gardens and paths. Any accumulation of moisture in the cladding system could be absorbed into the wall framing behind where it could cause deterioration, damage or both. Refer to photos 6-9.

There is less than recommended clearance between the base of the cladding and finished ground level. The cladding extends below ground level. As a result, it is at risk of absorbing moisture.

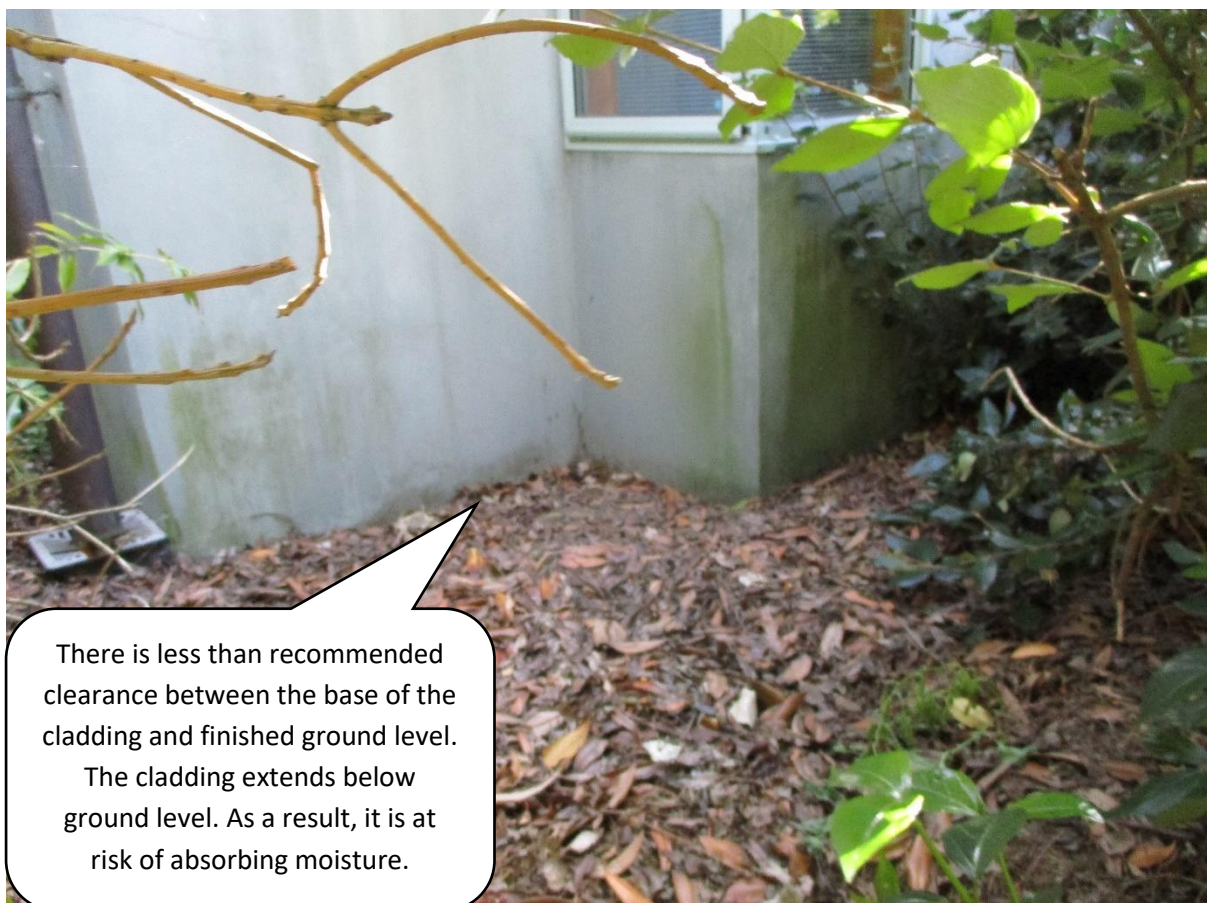
8.

There is less than recommended clearance between the base of the cladding and finished ground level.

The cladding extends below ground level. As a result, it is at risk of absorbing moisture.

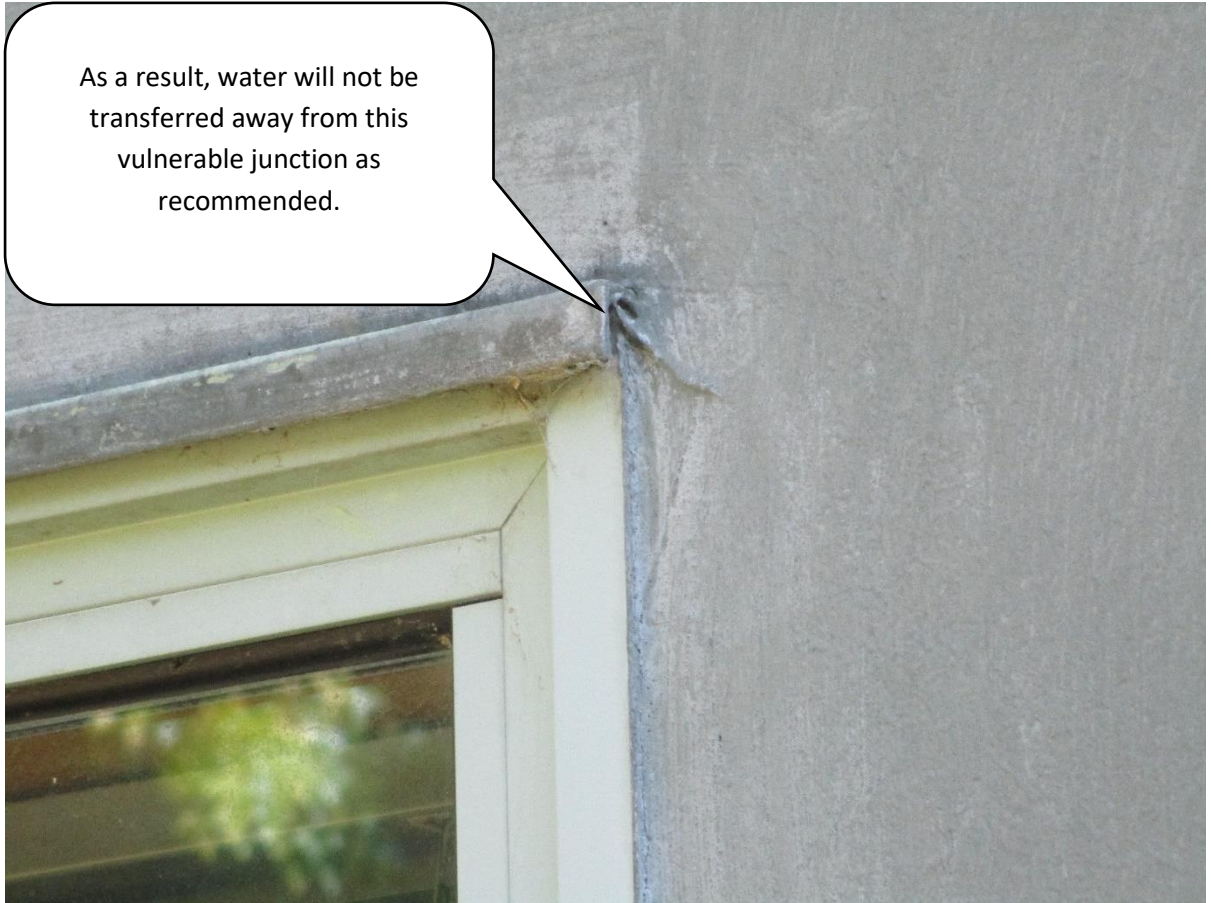
11.

Some head flashings on the south elevation windows do not extend past the sides of the frames the recommended 30mm. This extension is to transfer water away from the junction of the joinery and the cladding. The risk here is water could ingress at this vulnerable junction. Any water ingress behind the cladding could accumulate where it could cause deterioration, damage or both. Investigation of the interior adjacent to these windows revealed no elevated moisture readings or visual evidence of deterioration or damage. Notwithstanding established building science suggest it is likely water has ingressed at these locations. Refer to photos 10-12.

The staining shows how water is not being transferred away from this vulnerable junction as recommended.

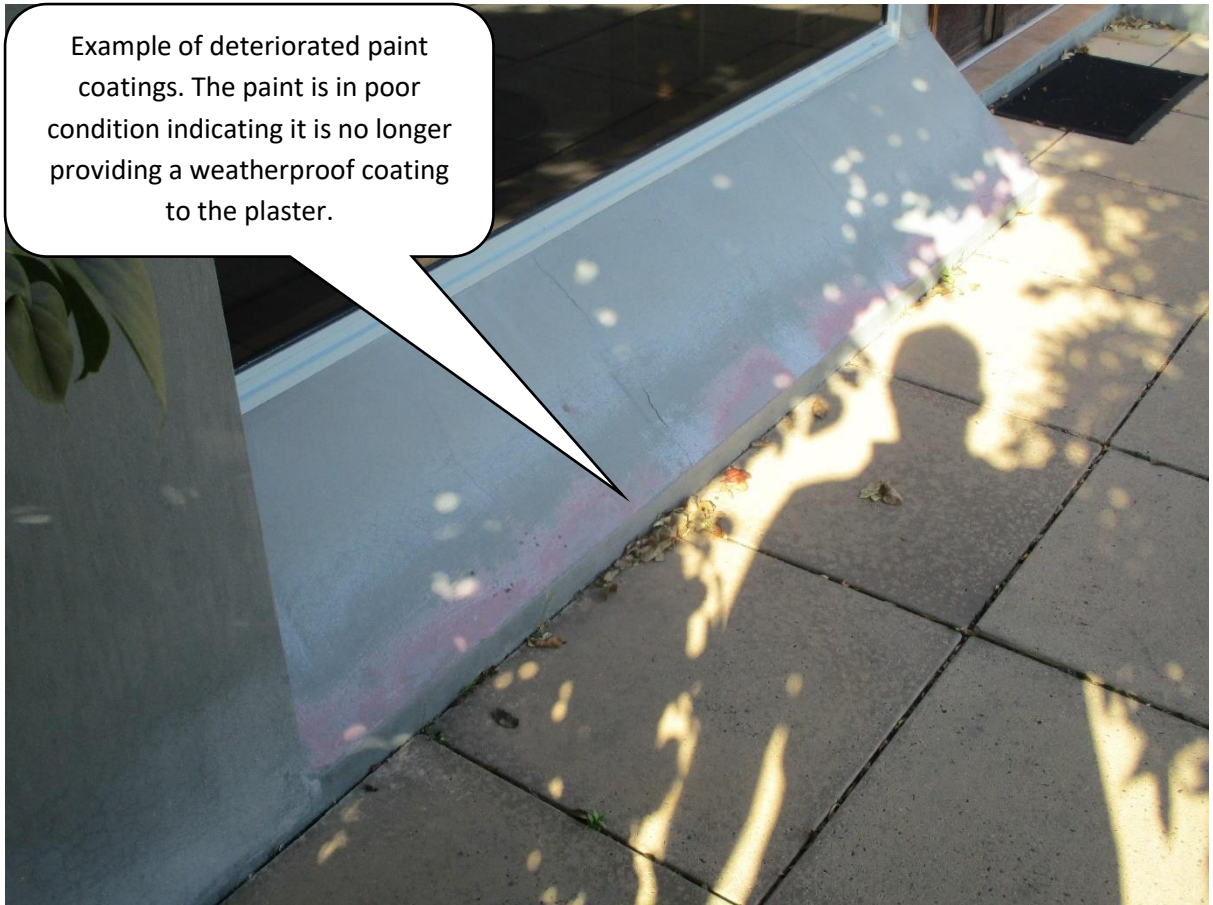
19.

The condition of the paint and plaster system indicates it is due for urgent repair. Fading of the paint, hairline cracks and deterioration of the seals around penetrations were all identified. All of these defects could allow water past the face seal of the plaster cladding into the wall frame where it could accumulate and cause deterioration, damage or both. Refer to photos 19-28.

Example of deteriorated paint coatings. The paint is in poor condition indicating it is no longer providing a weatherproof coating to the plaster.

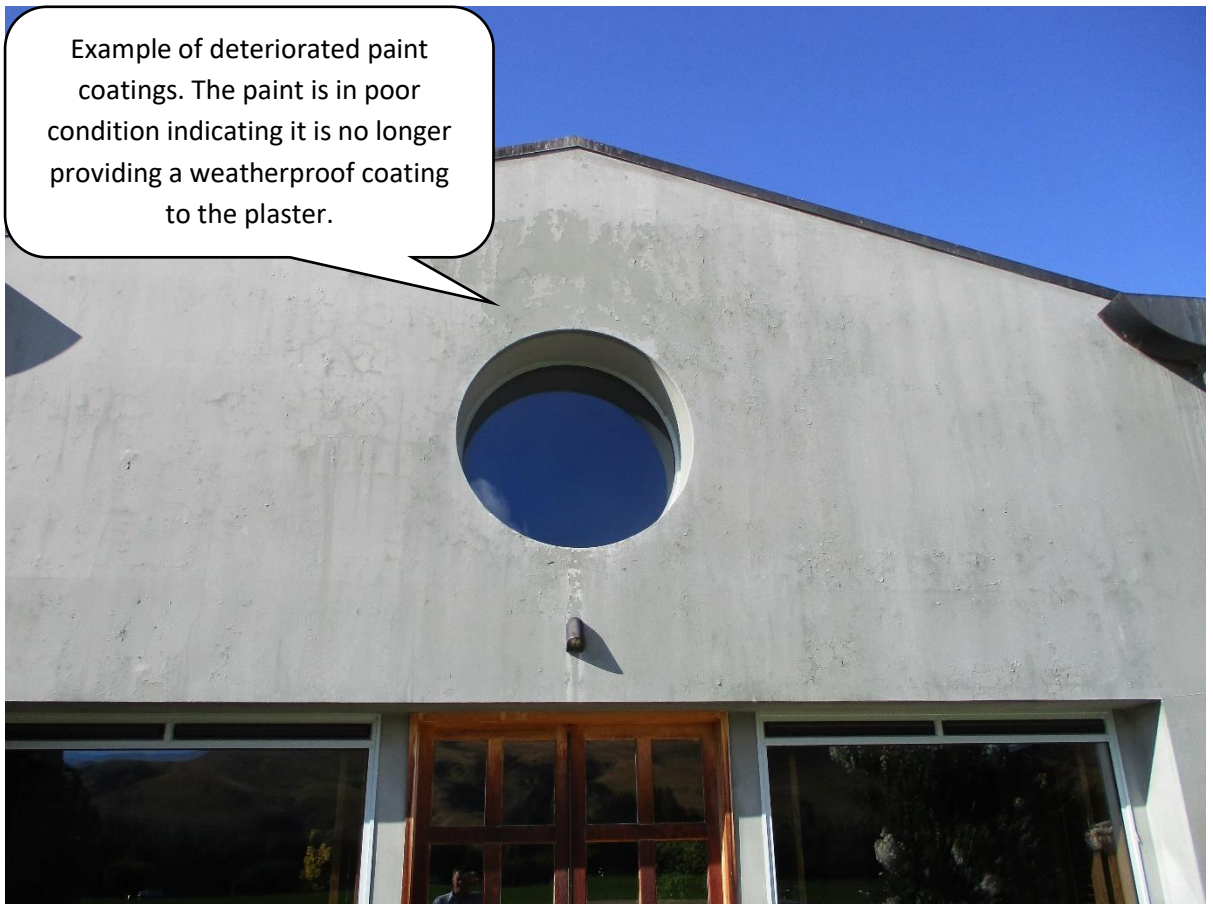
20.

Example of deteriorated paint coatings. The paint is in poor condition indicating it is no longer providing a weatherproof coating to the plaster.

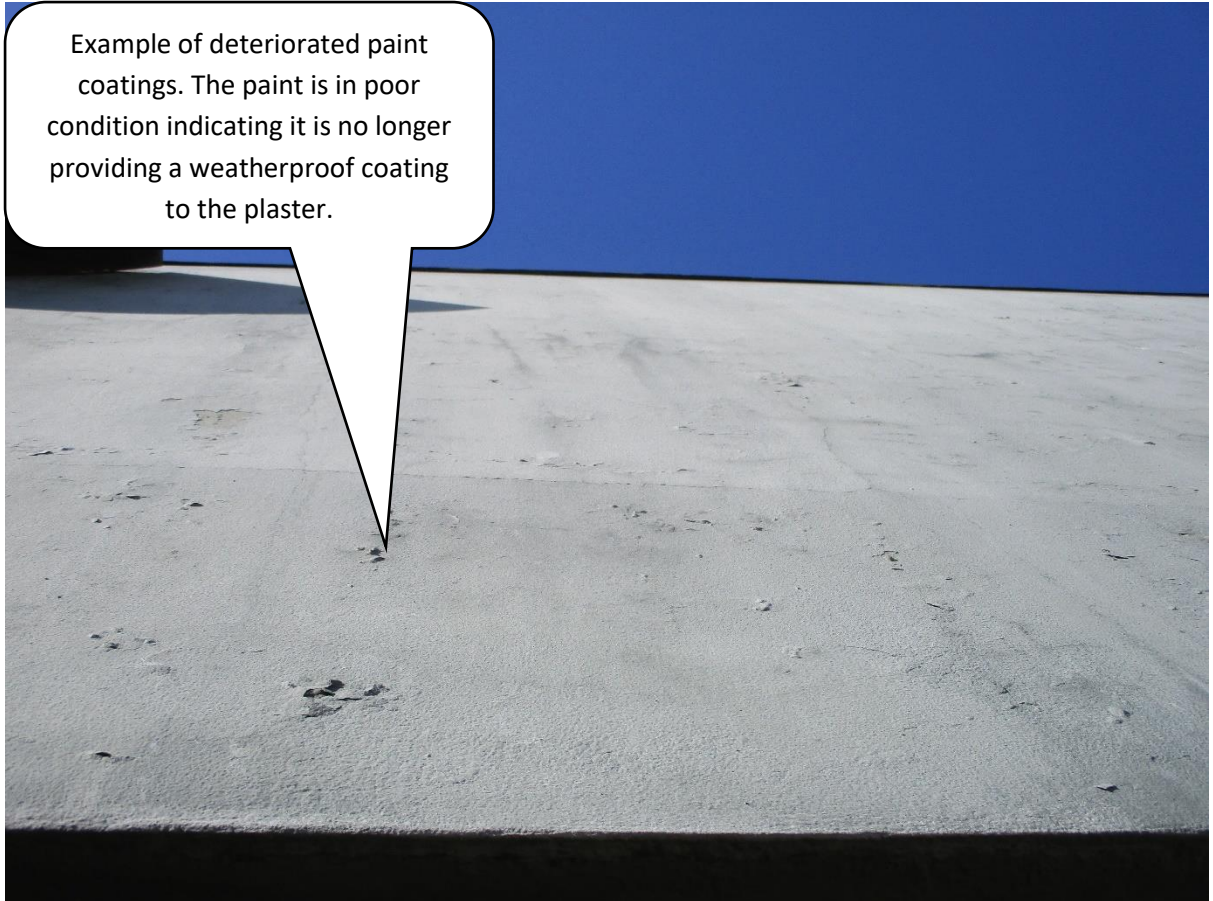
21.

Example of deteriorated paint coatings. The paint is in poor condition indicating it is no longer providing a weatherproof coating to the plaster.

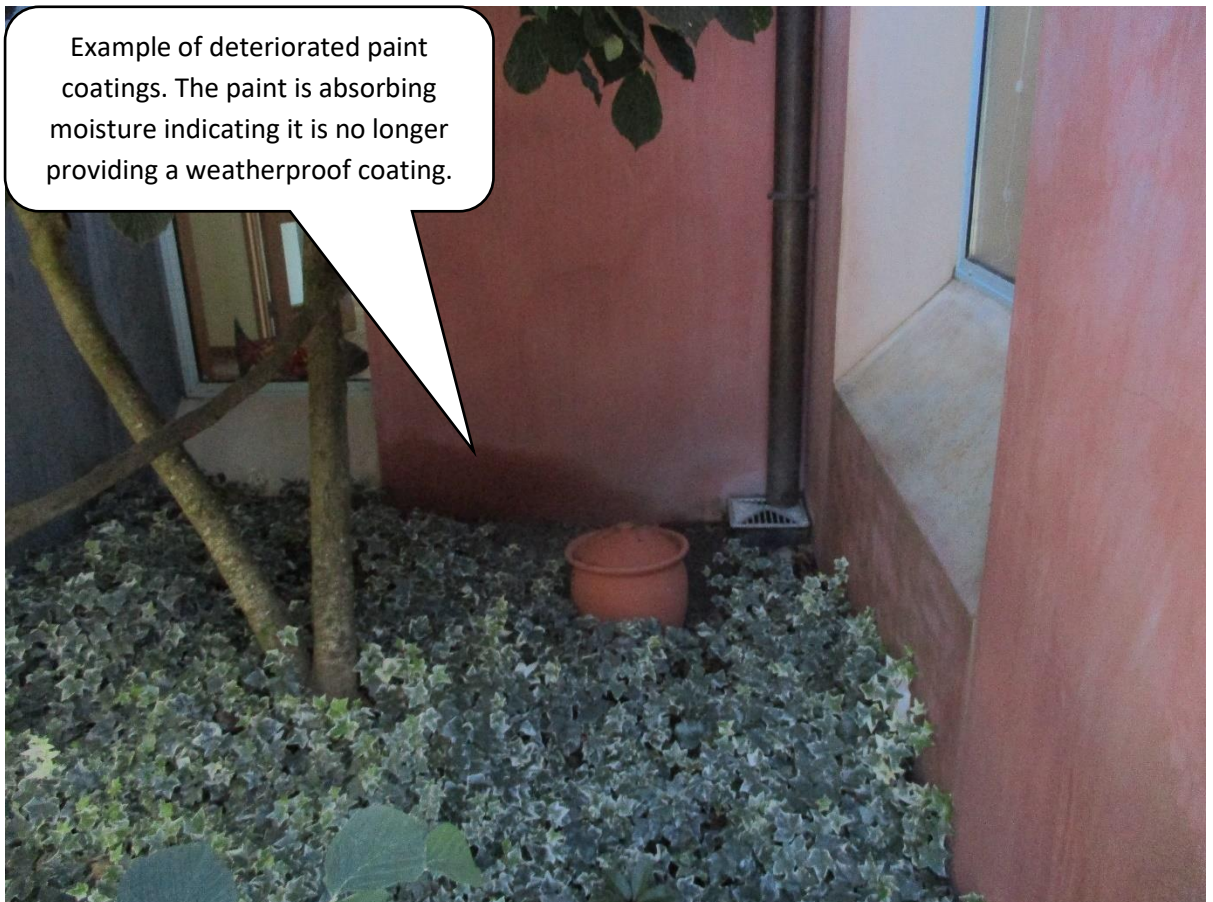
22.

Example of deteriorated paint coatings. The paint is absorbing moisture indicating it is no longer providing a weatherproof coating.

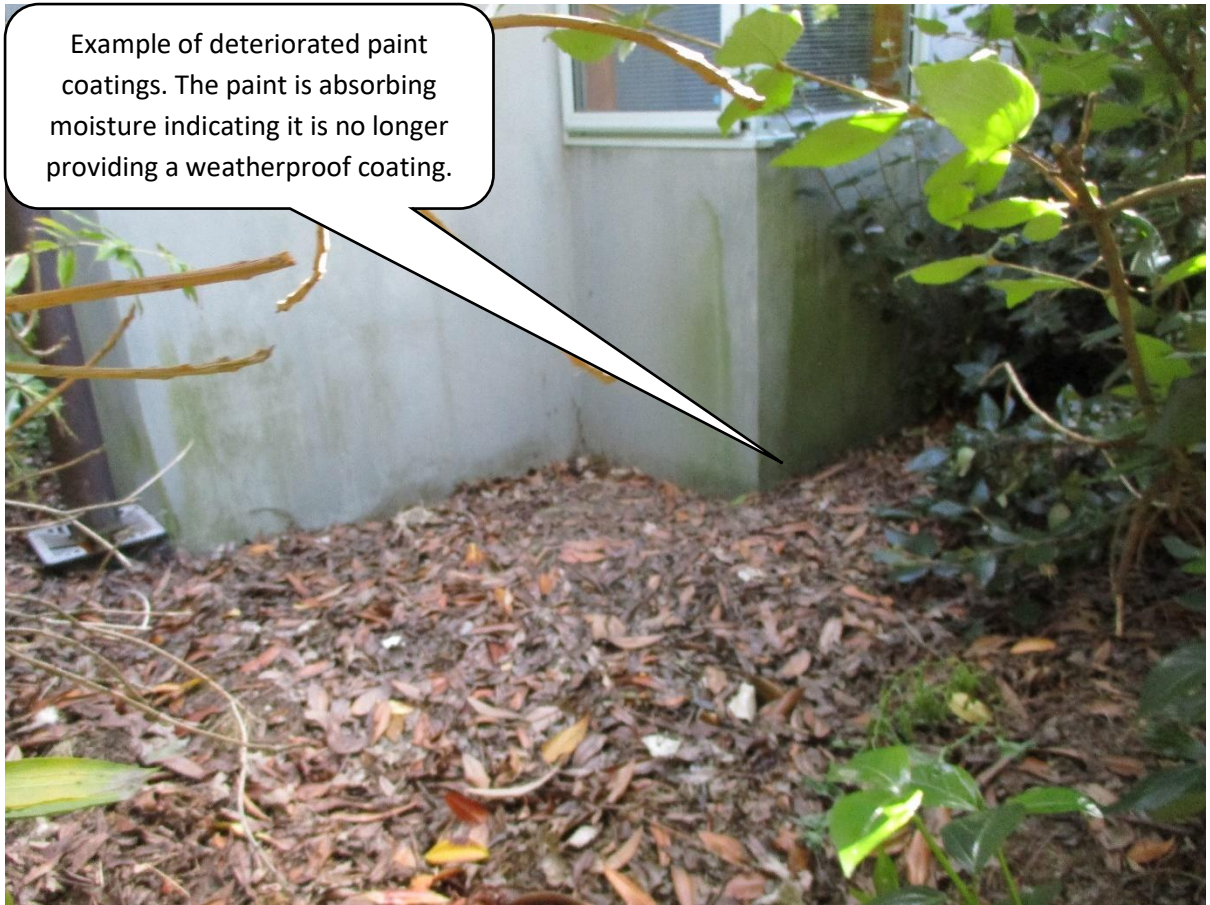
23.

Example of deteriorated paint coatings. The paint is absorbing moisture indicating it is no longer providing a weatherproof coating.

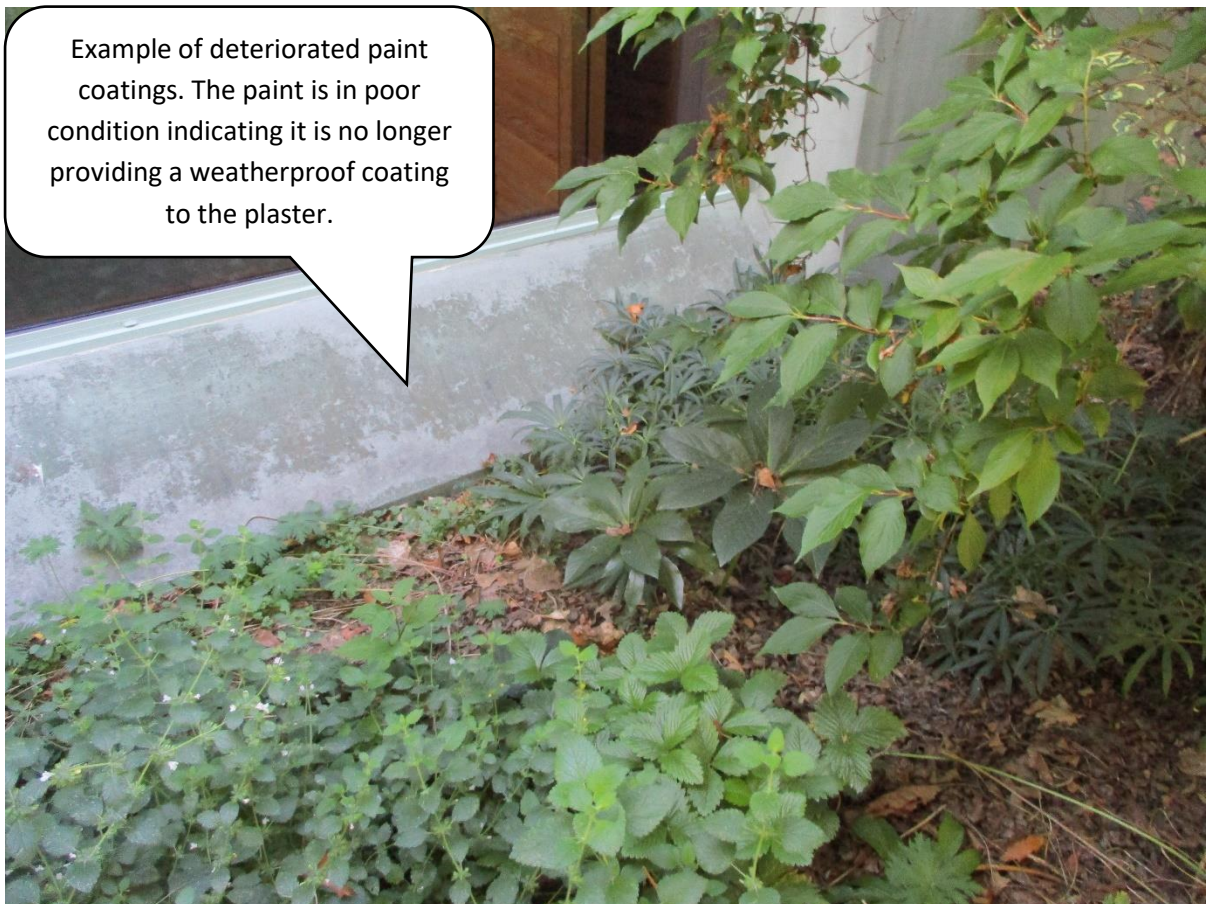
24.

Example of deteriorated paint coatings. The paint is in poor condition indicating it is no longer providing a weatherproof coating to the plaster.

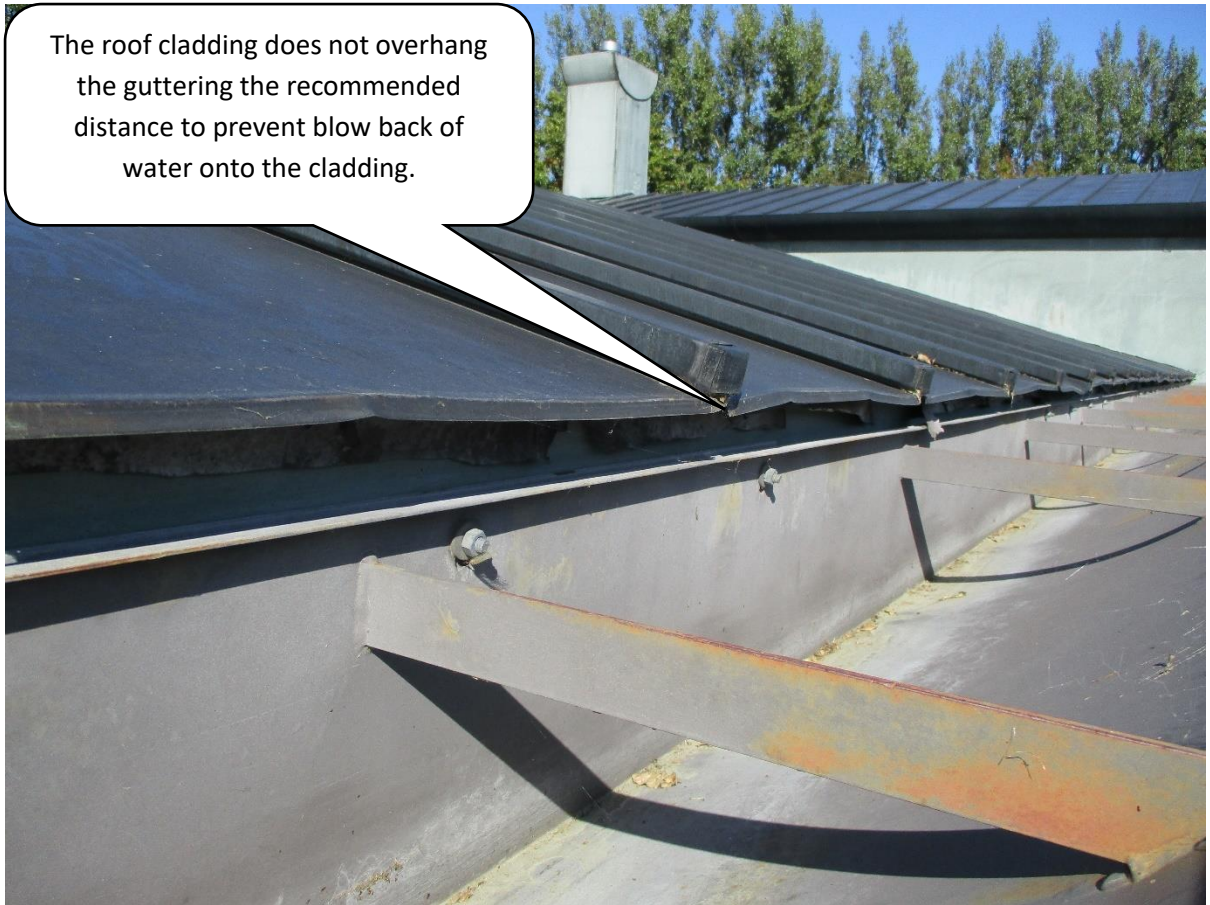
33.

The roof cladding does not overhang the guttering the recommended distance in places. This overhang is to prevent blow back of the water discharging off the roof cladding. Any blown back water could come in contact with the un-finished top edge of the cladding or be transported over the top of the wall cladding. This water could then accumulate and cause deterioration damage or both. There is evidence of water staining on the exterior walls below the guttering suggesting blow back is occurring. Refer to photos 33-36.

The roof cladding does not overhang the guttering the recommended distance to prevent blow back of water onto the cladding.

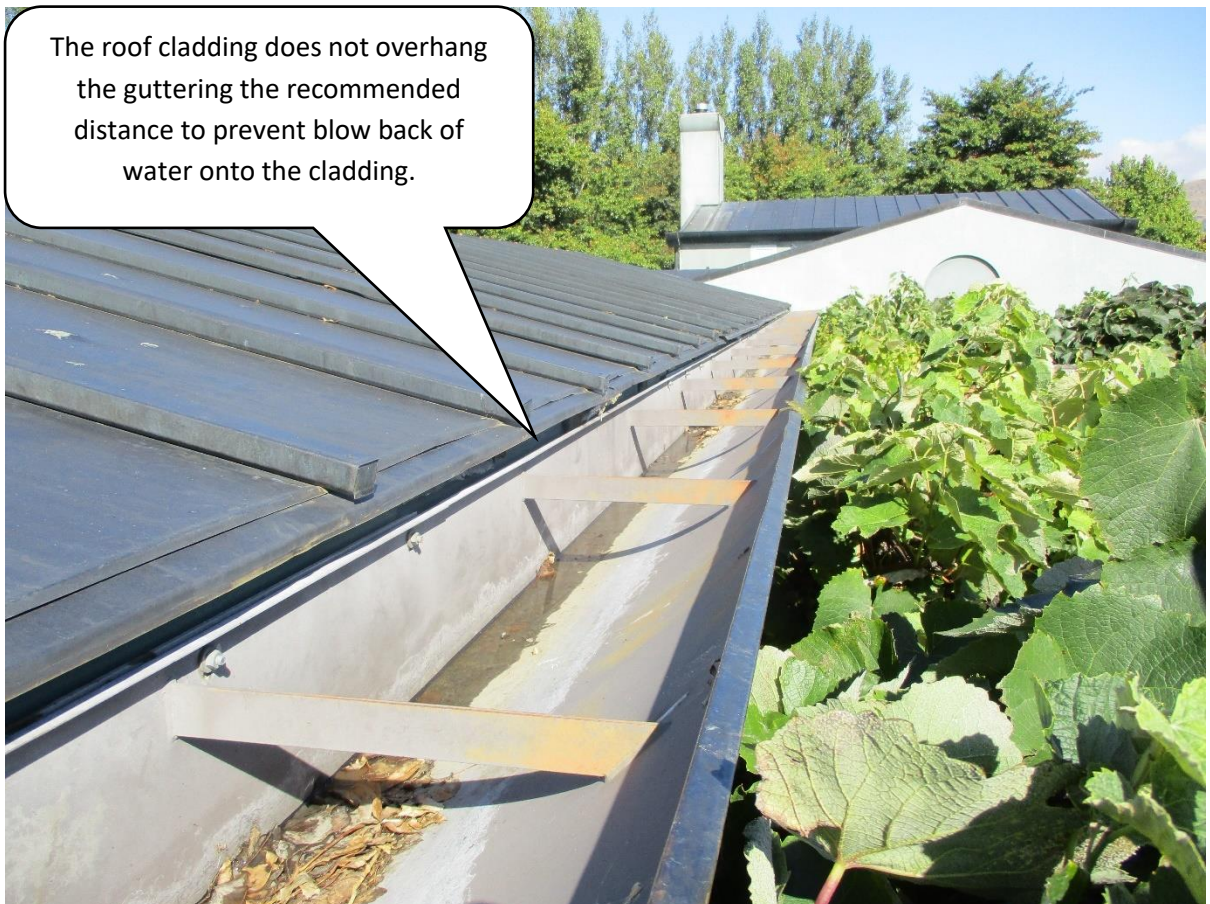
34.

The roof cladding does not overhang the guttering the recommended distance to prevent blow back of water onto the cladding.

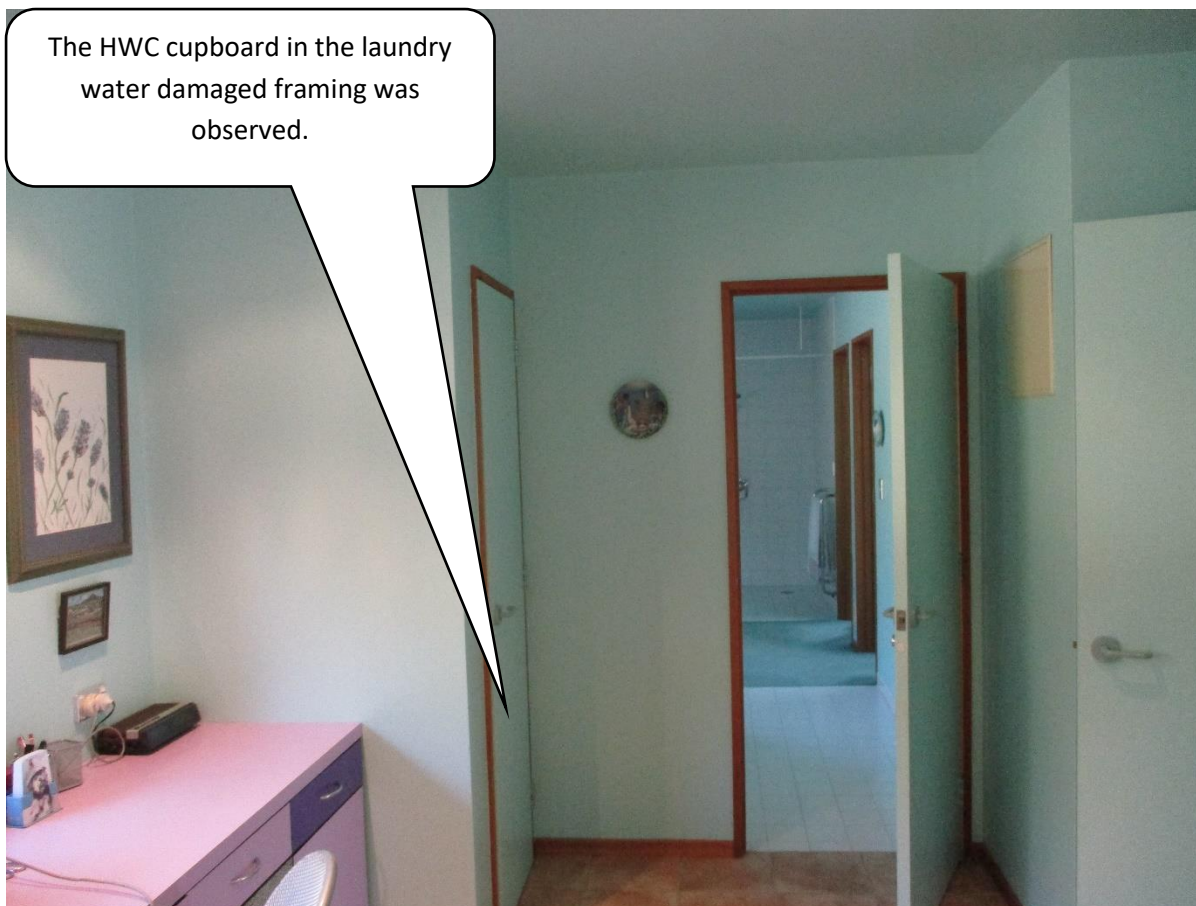
39.

Some deterioration to the timber framing was observed below the HWC in the laundry. The exact cause of this deterioration was not established but is adjacent to a number of weathertightness risk features. Refer to photos 39-40

The HWC cupboard in the laundry water damaged framing was observed.

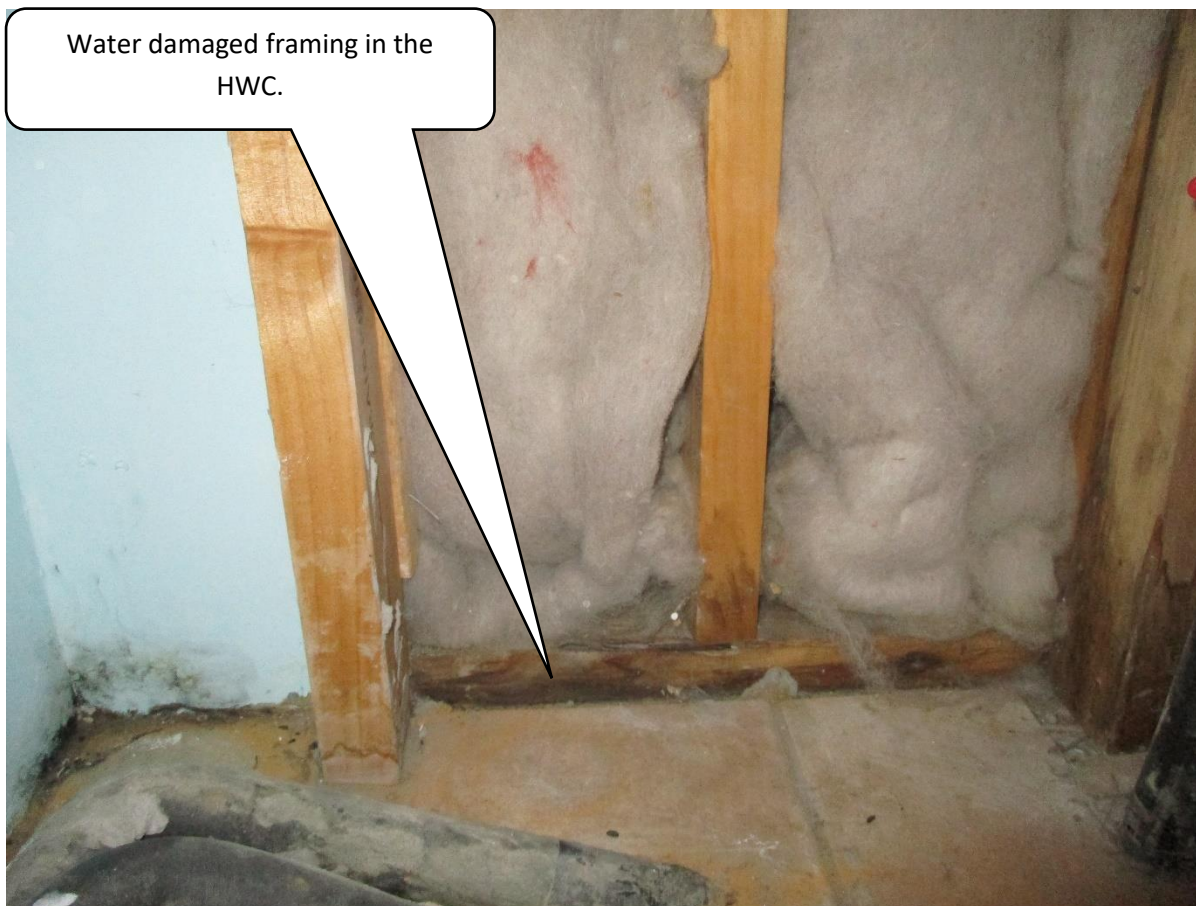
40.

Water damaged framing in the HWC.

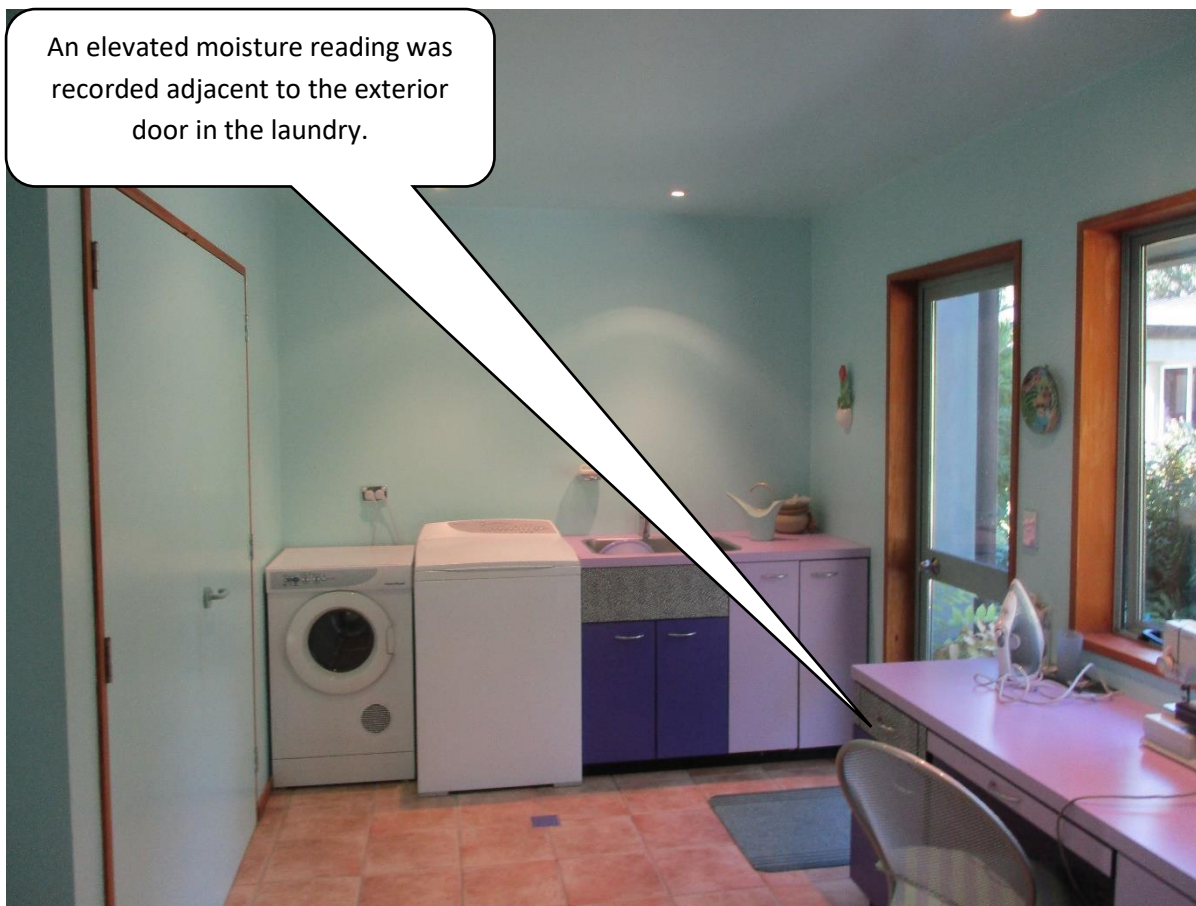
41.

An elevated moisture reading was recorded in the wall linings adjacent to the exterior door in the laundry. The exact cause of this elevated reading was not established but is adjacent to a number of weathertightness risk features. Refer to photos 41-42.

An elevated moisture reading was recorded adjacent to the exterior door in the laundry.

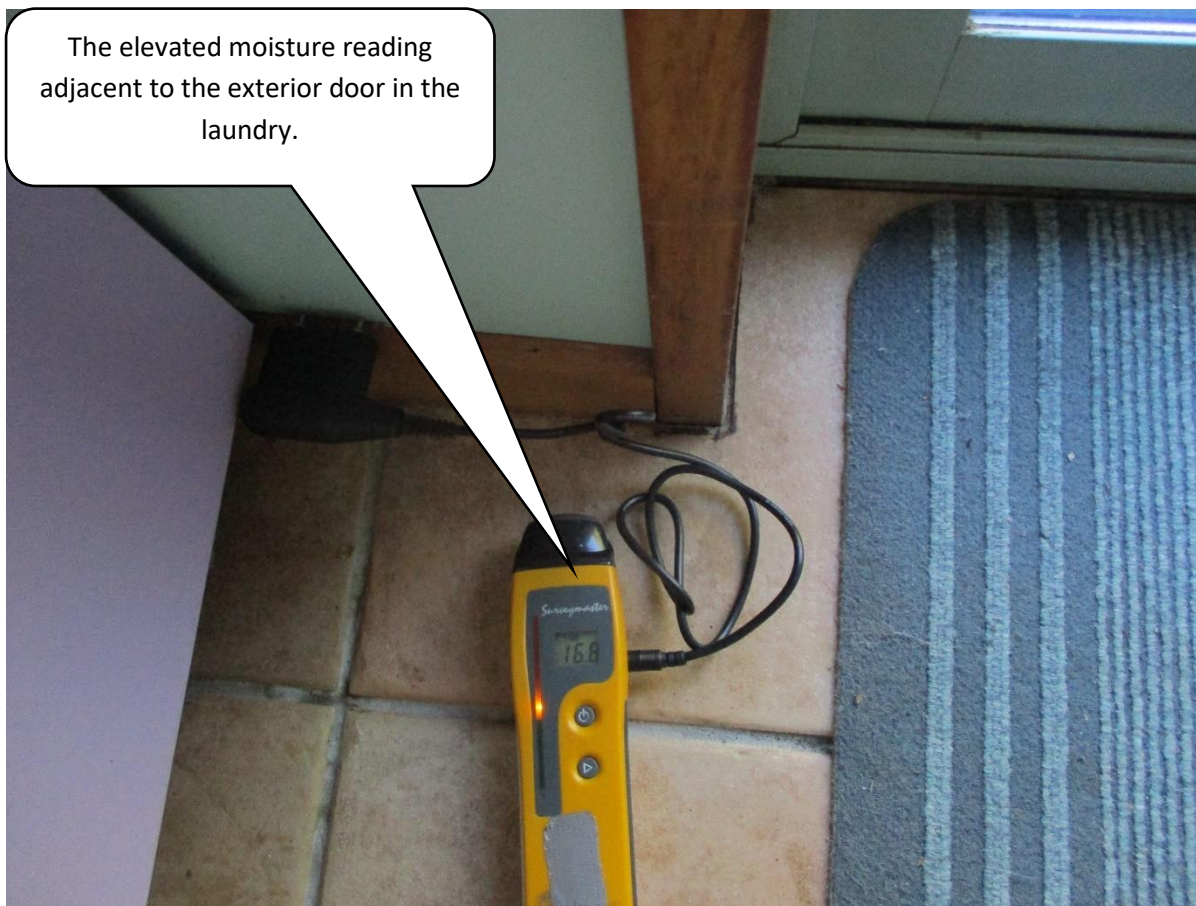
42.

The elevated moisture reading adjacent to the exterior door in the laundry.

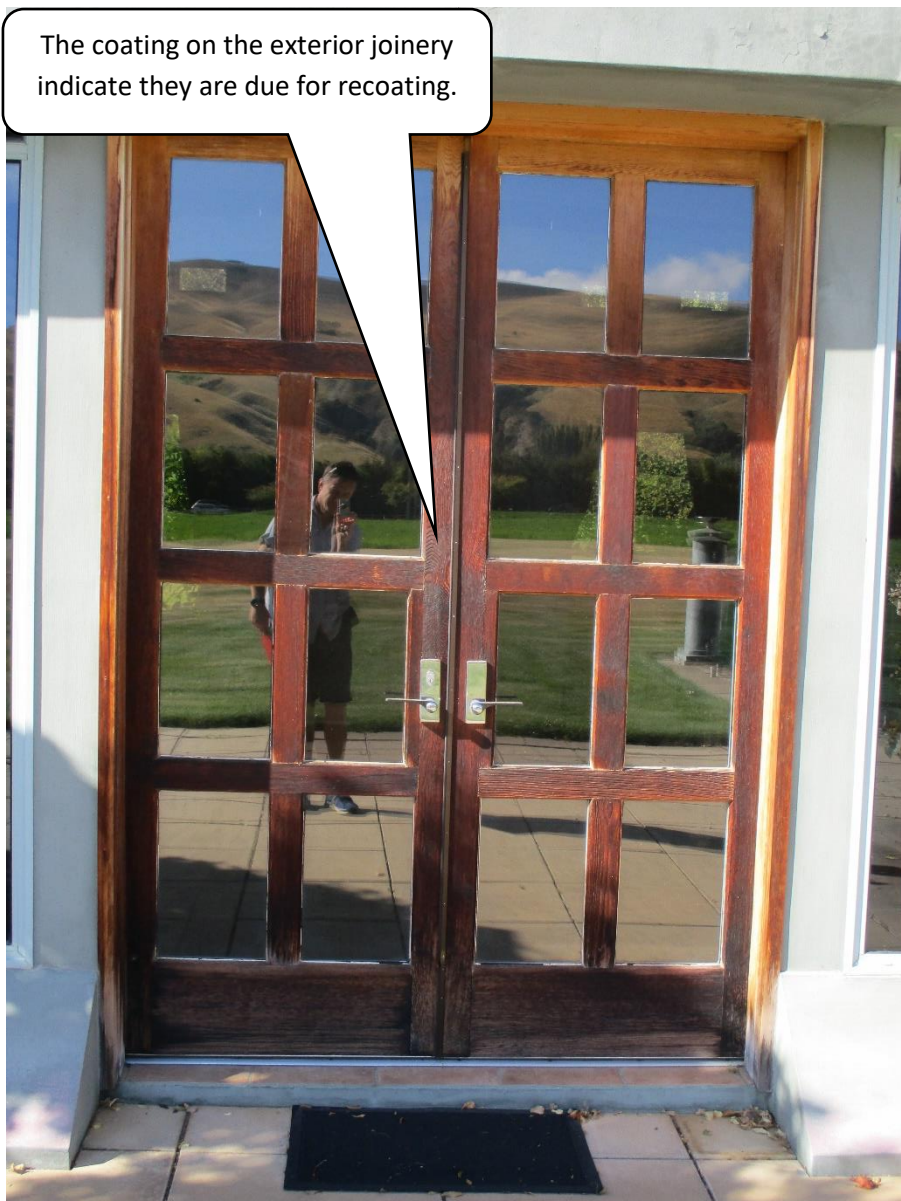
- 12.2 Overall, the exterior wall system of the dwelling requires some attention. Refer to observations 9.2 1-6. The protective coating on the timber exterior windows is in poor condition and is no longer providing protection to the wood from the elements. Refer to photo 45.

The coating on the exterior joinery indicate they are due for recoating.

1. Any plants touching the exterior cladding should be cut back.
2. The protective coating on the timber doors should be replaced.
3. All gutters should be cleaned.
4. All gutters should be checked for leaks and repairs made.
5. A suitably qualified engineer should be engaged to comment on the cracks in the floor and exterior walls of the garage.
6. Any stiff or hard to operate doors should be repaired.
7. All noisy extractor fans in the ensuite bathrooms and toilets should be replaced.
8. The grouting and seals in all showers should be checked and repaired where required.
9. The cause of the unidentified water stains in the office and living area should be investigated.
10. The cause of the mould in the roof space above the laundry should be investigated.

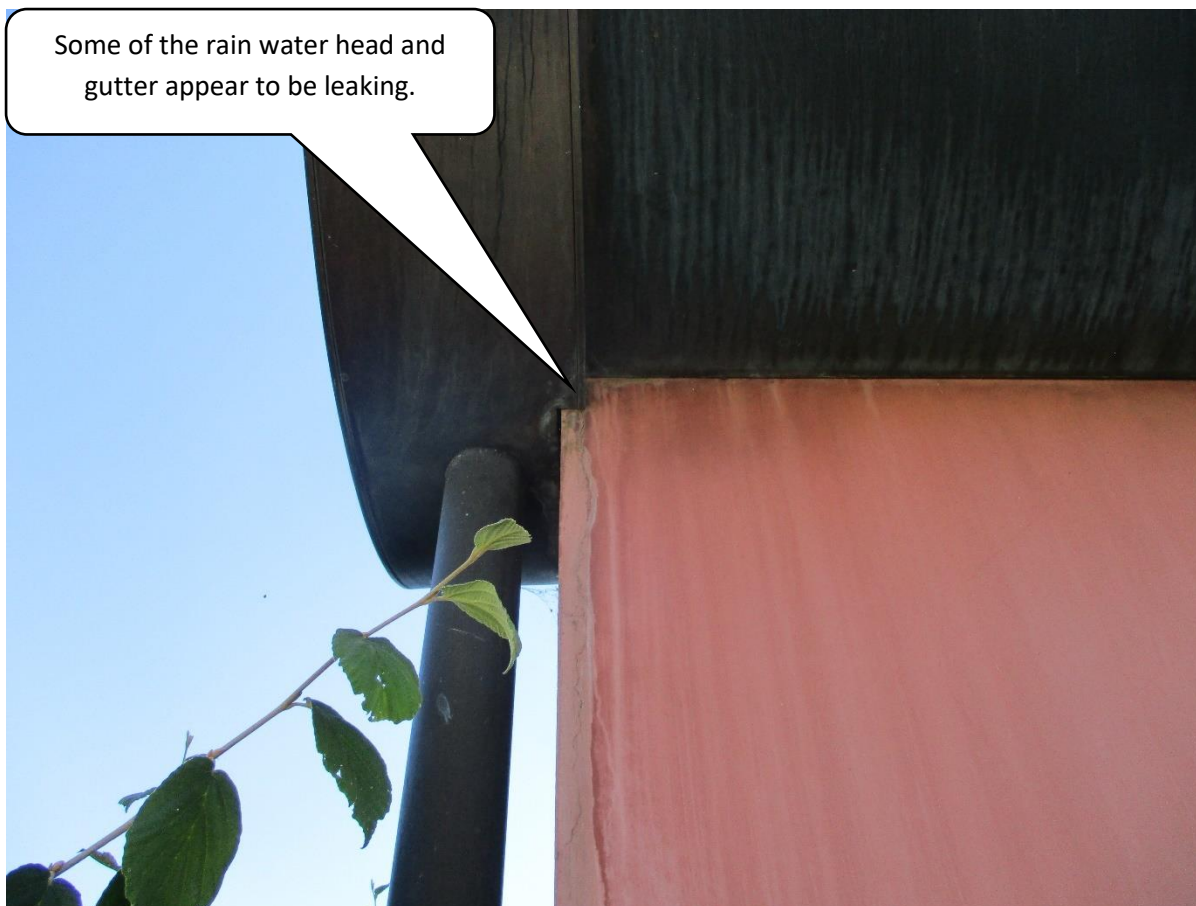
46.

Some of the rain water head and gutter appear to be leaking.

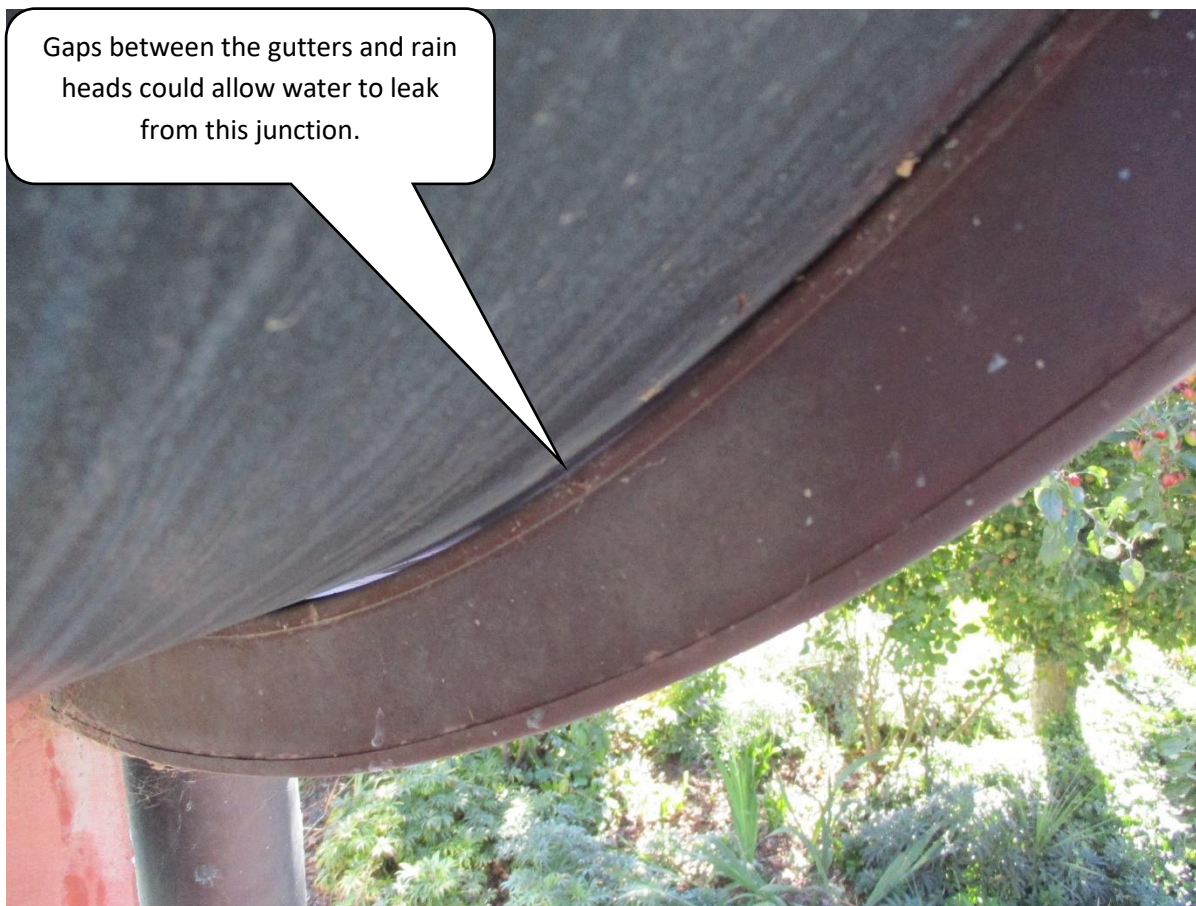
47.

Gaps between the gutters and rain heads could allow water to leak from this junction.

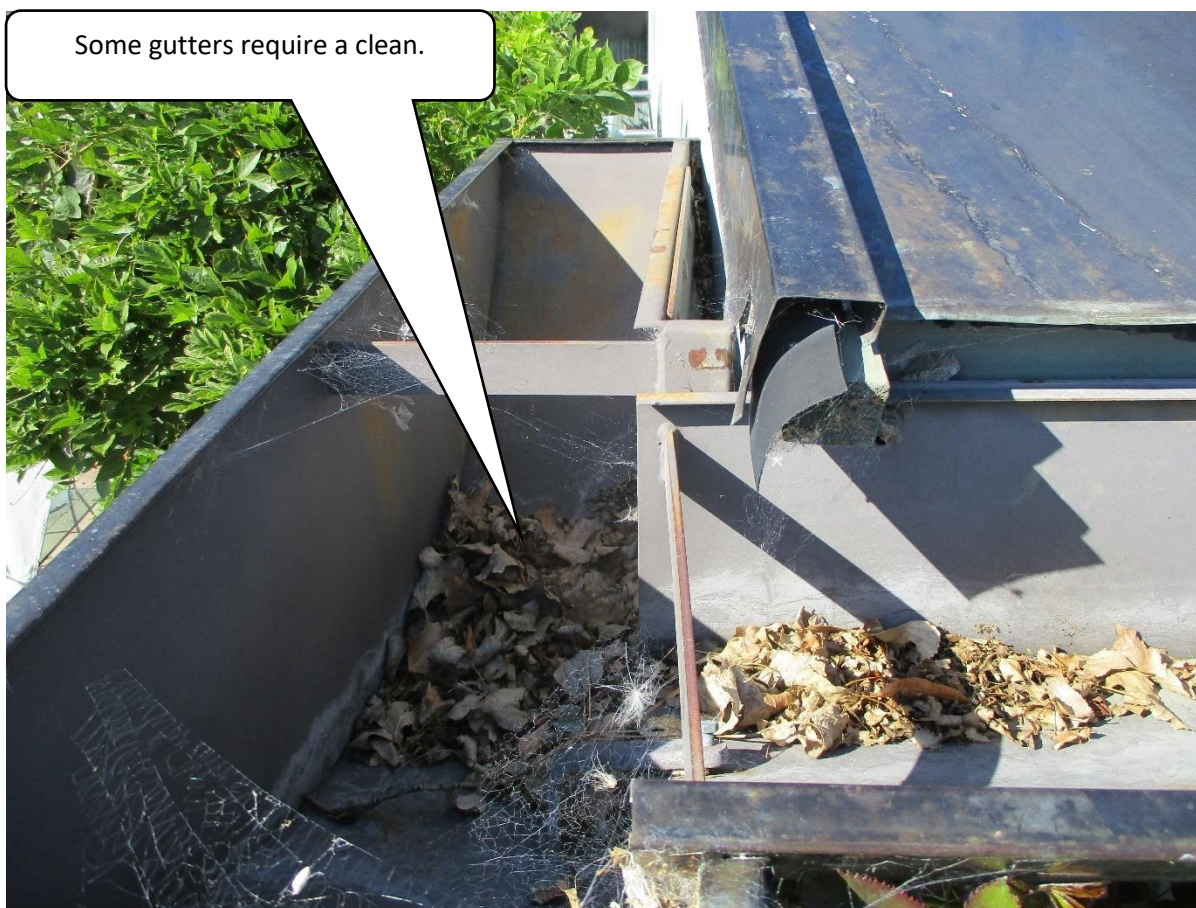
49.

Some gutters require a clean.
