## **BUILDING SURVEYORS REPORT**

### **Weathertightness Risk and Building Condition Assessment**

516 Frankton Ladies Mile Highway

26 March 2019

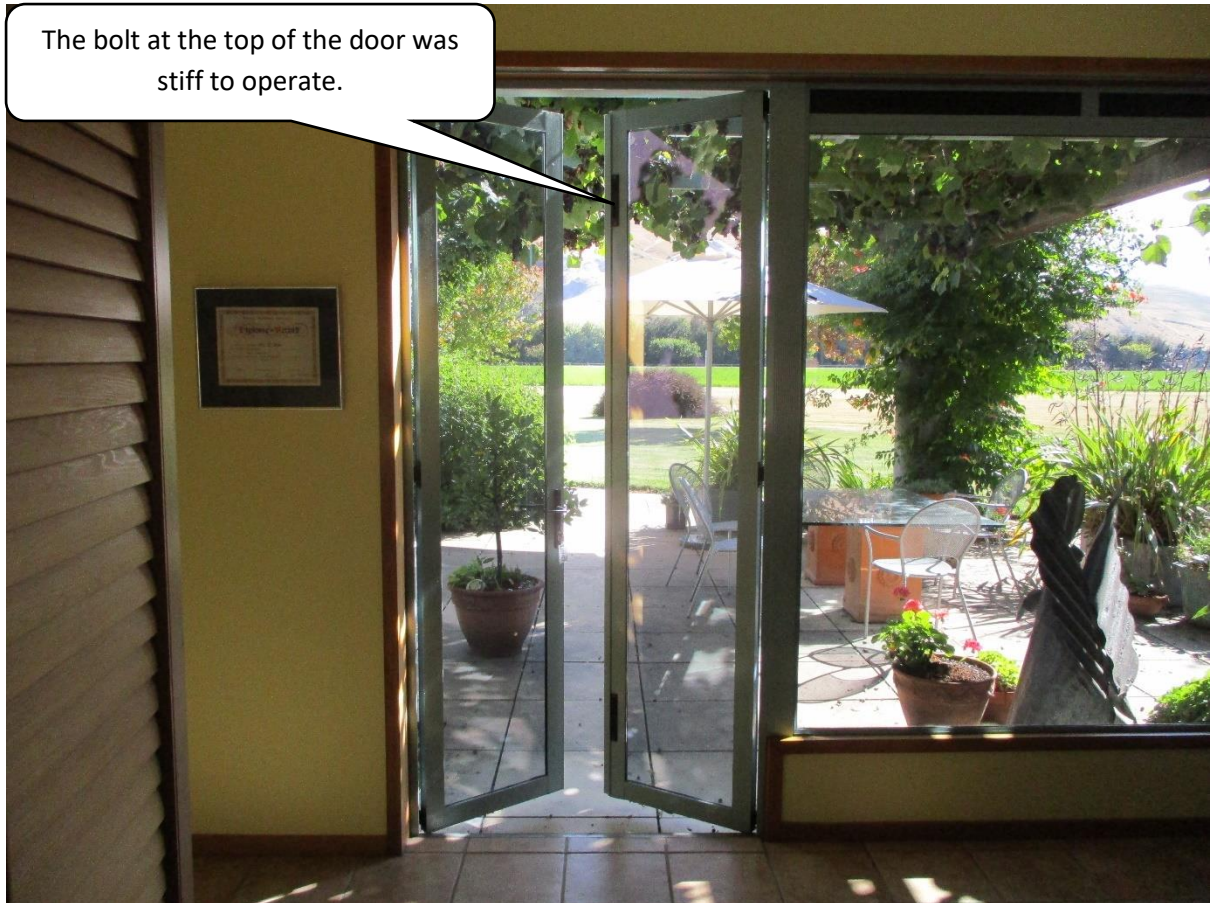
58.

The bolt at the top of the door was stiff to operate.

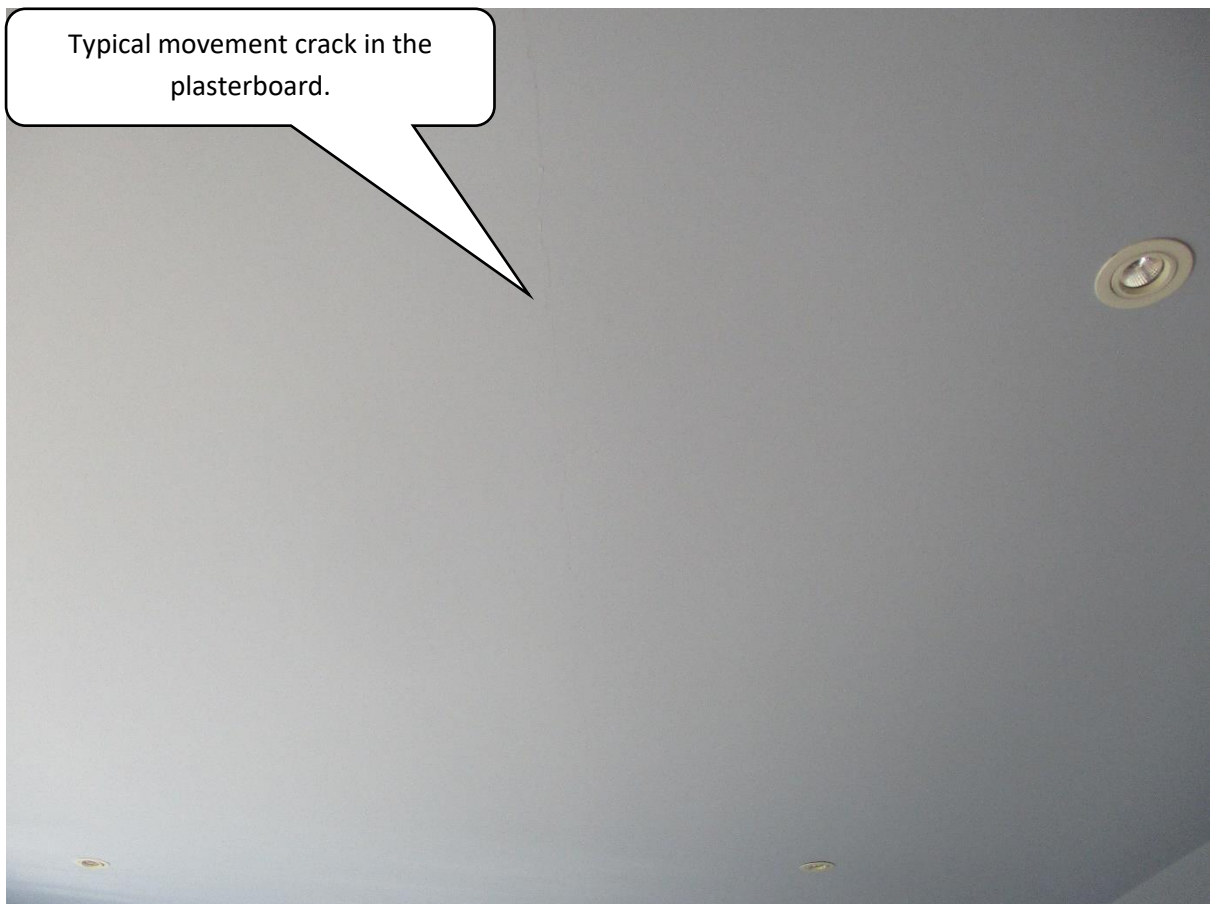
59.

Typical movement crack in the plasterboard.

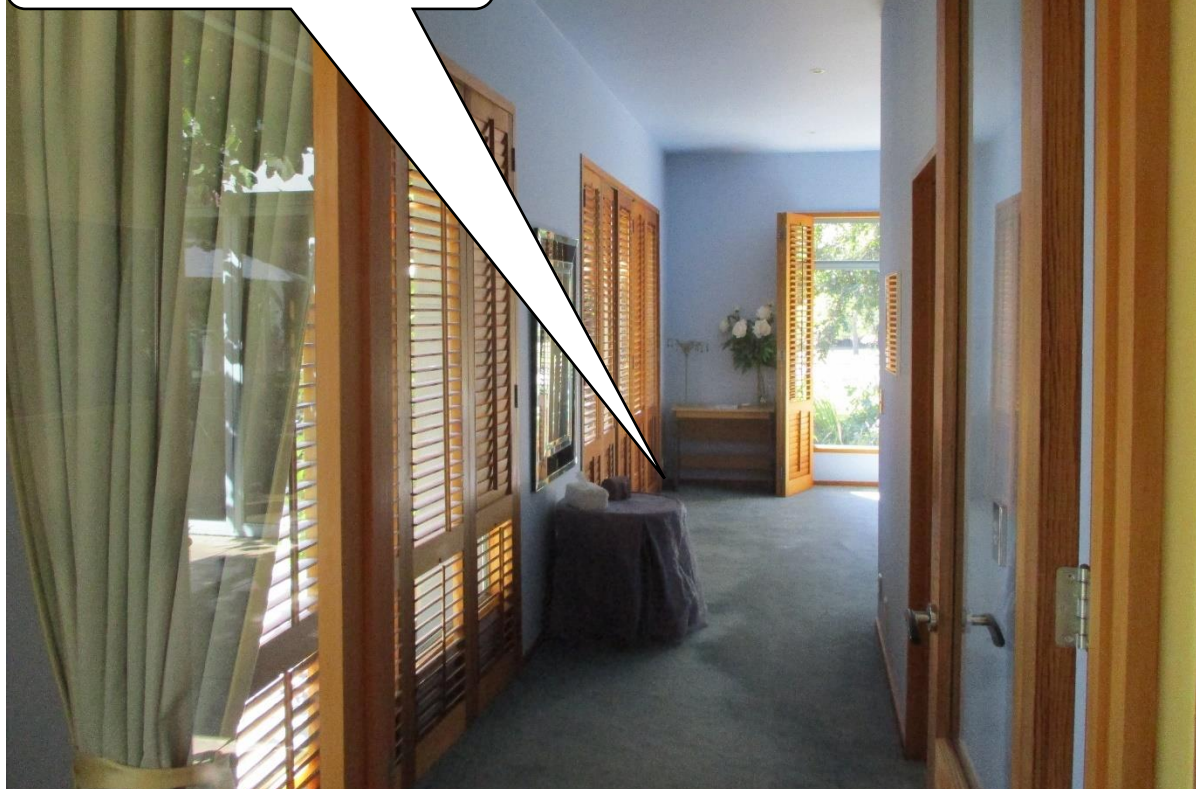
60.

Some water damaged carpet was identified in the north east corner of bedroom 4. The exact cause of this deterioration was not established but is adjacent to a number of weathertightness risk features. Refer to photos 37-38.

Location of the water damaged carpet.

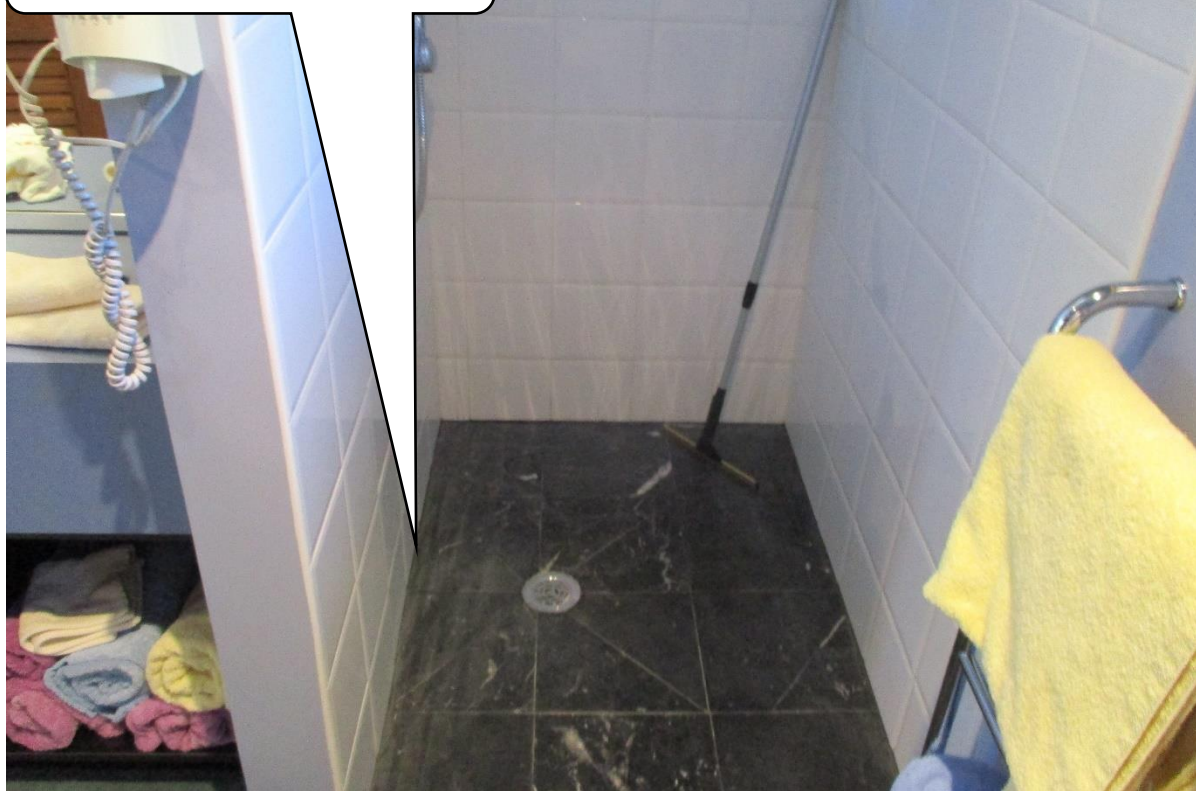
61.

The grout and seal at the base of the shower is due for maintenance.

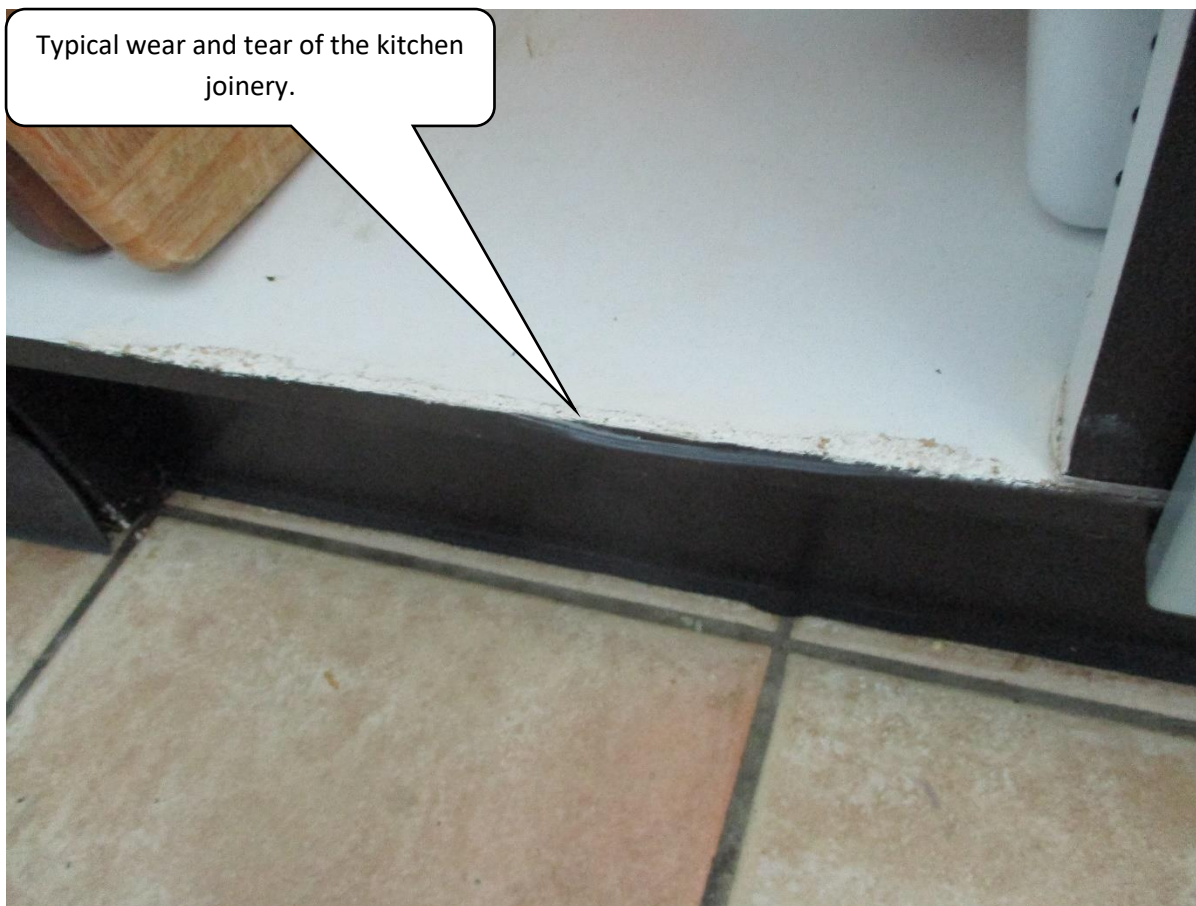
62.

Typical wear and tear of the kitchen joinery.

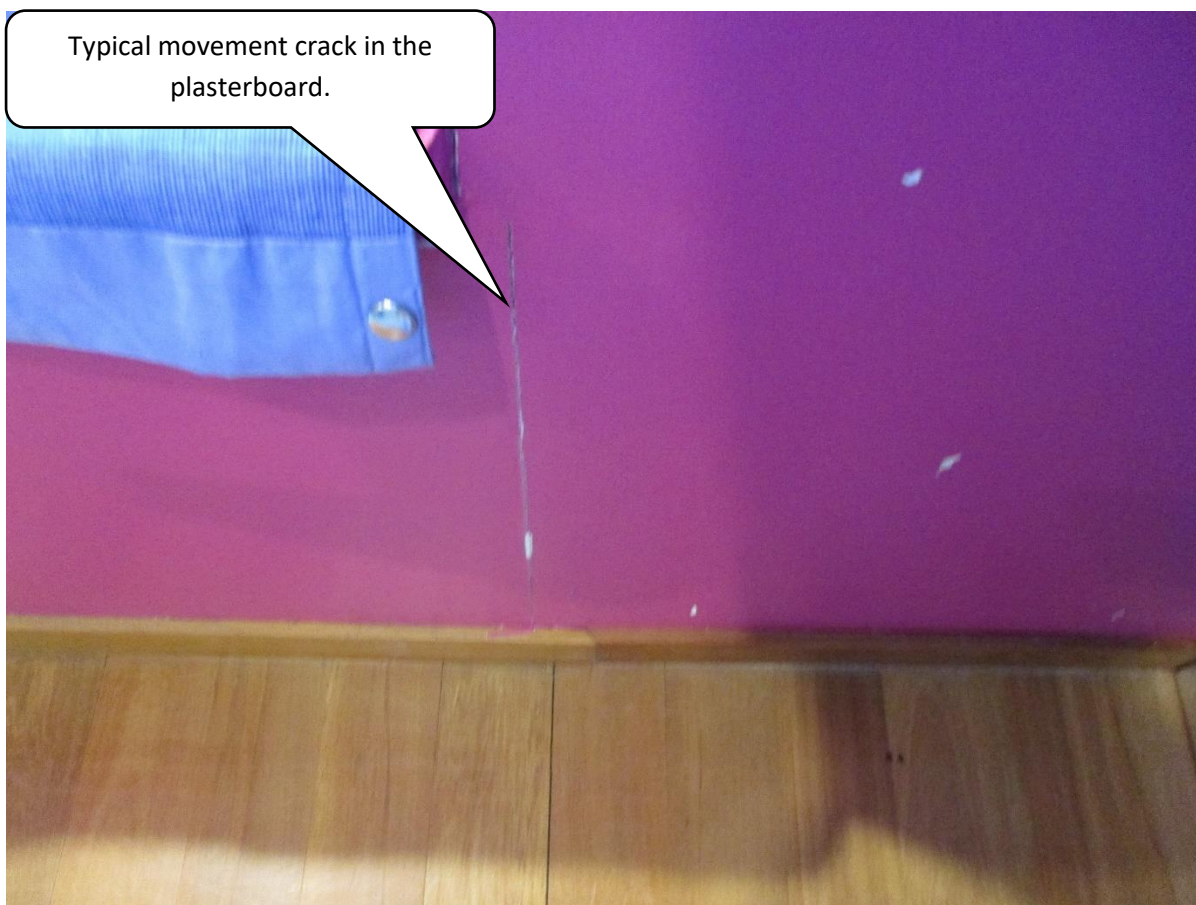
63.

Typical movement crack in the plasterboard.

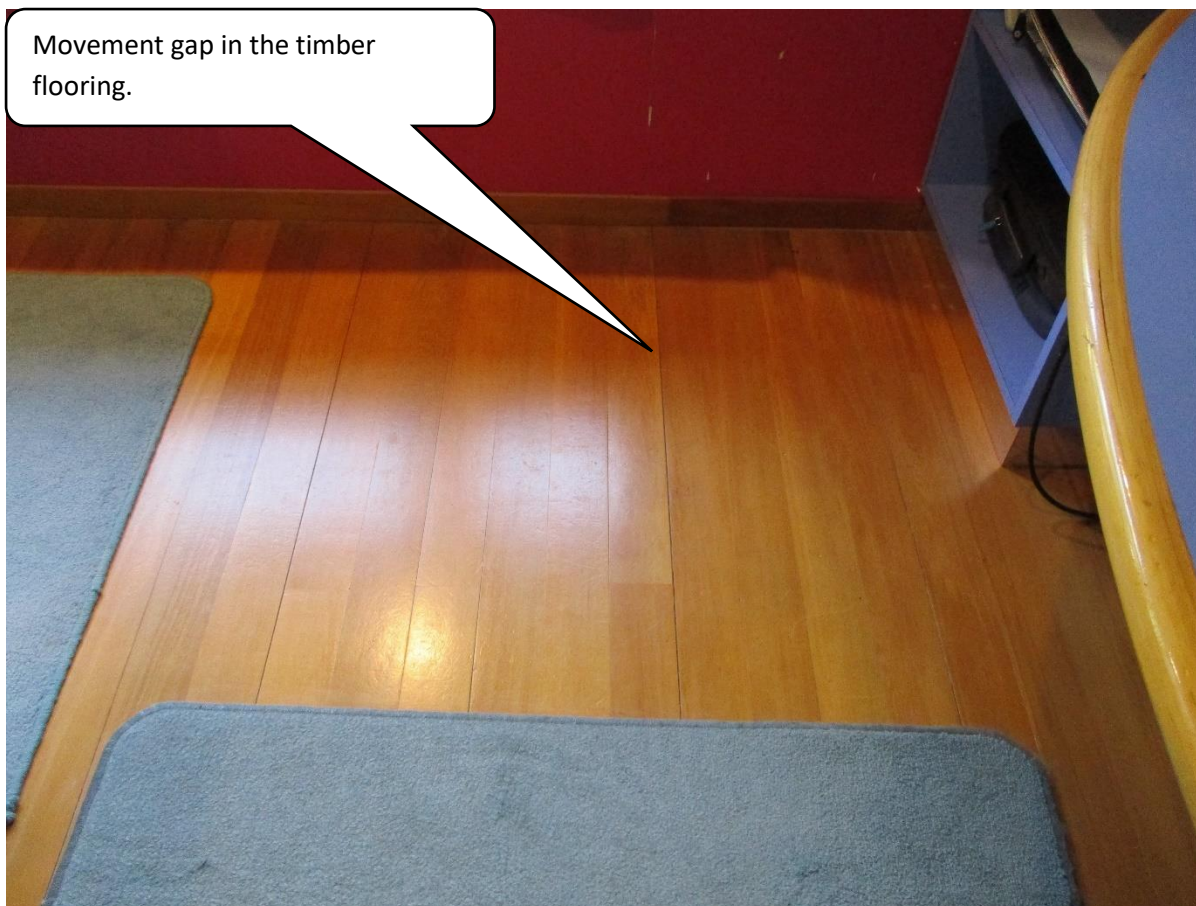
64.

Movement gap in the timber flooring.

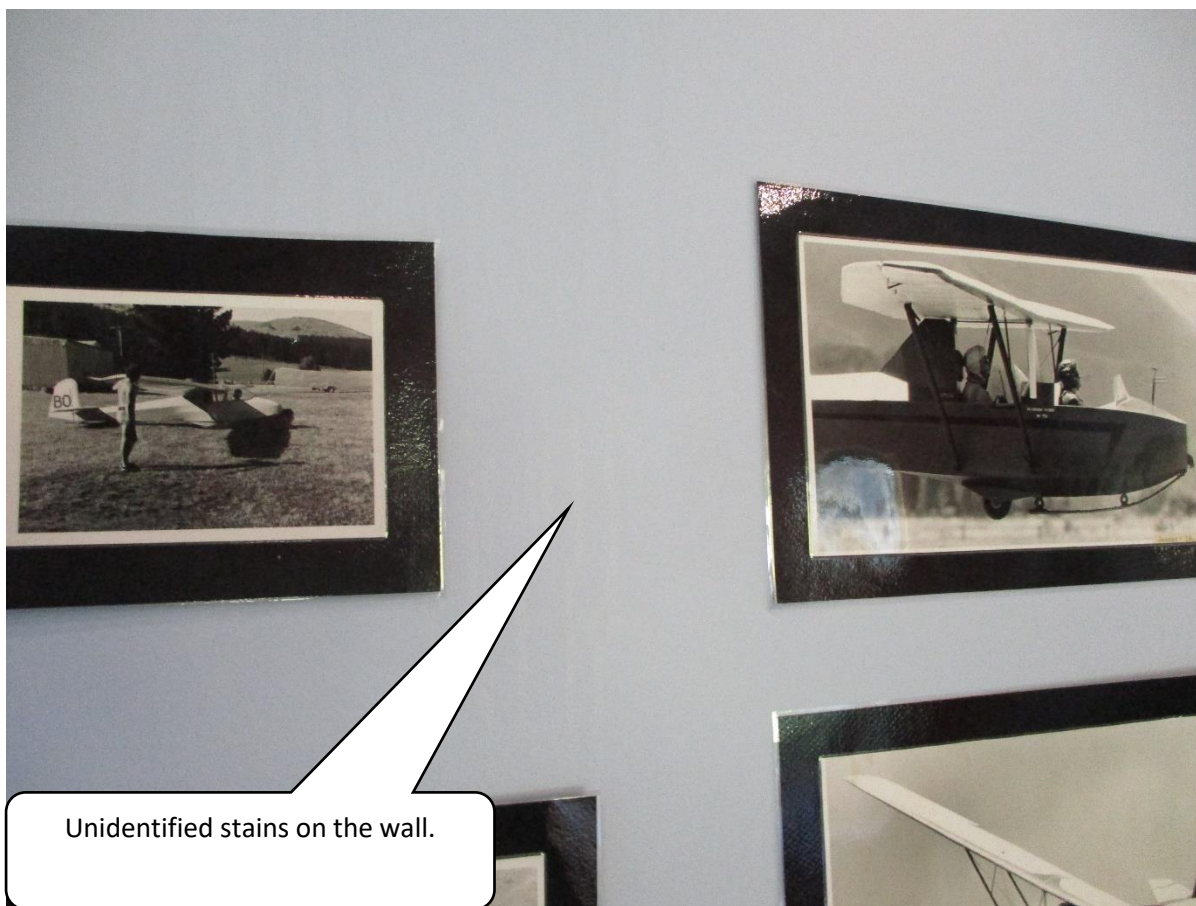
65.

Unidentified stains on the wall.

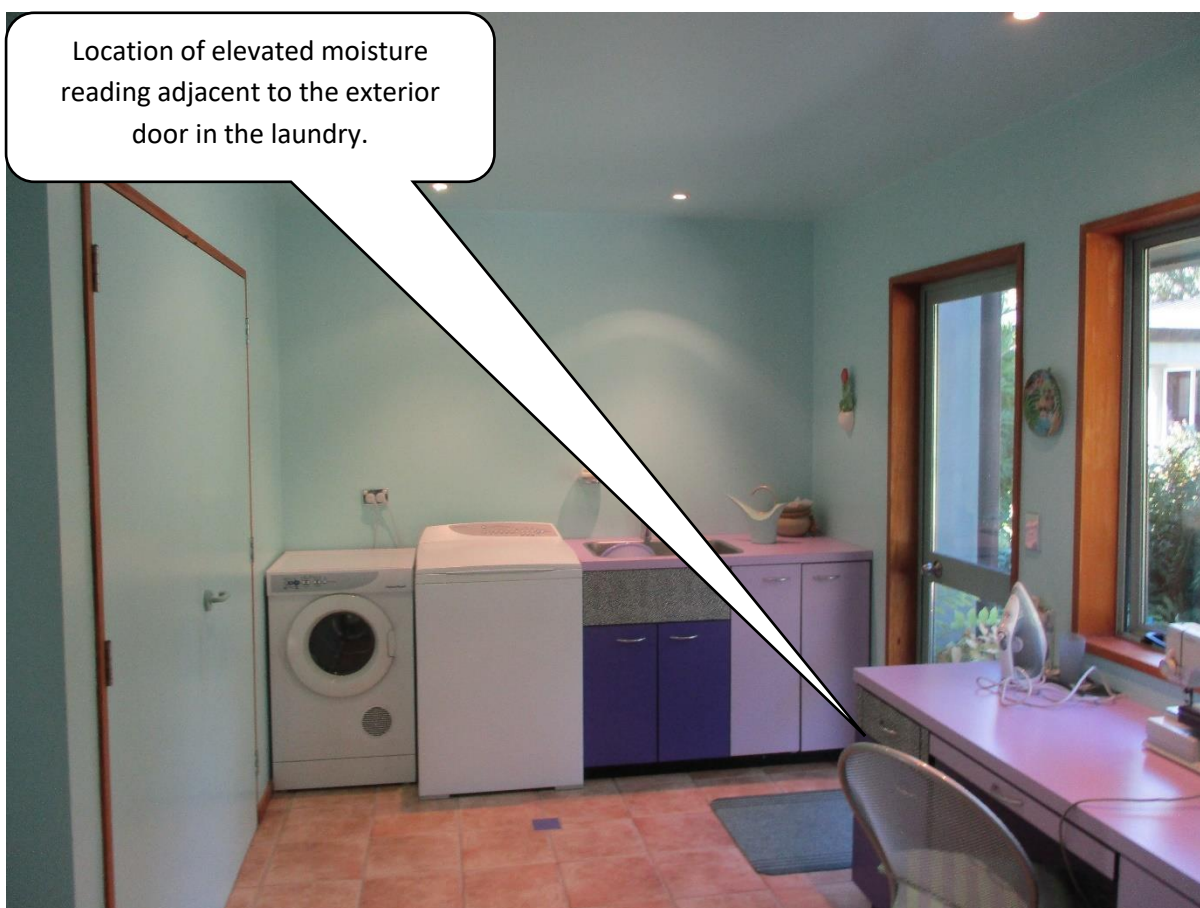
71.

Location of elevated moisture reading adjacent to the exterior door in the laundry.

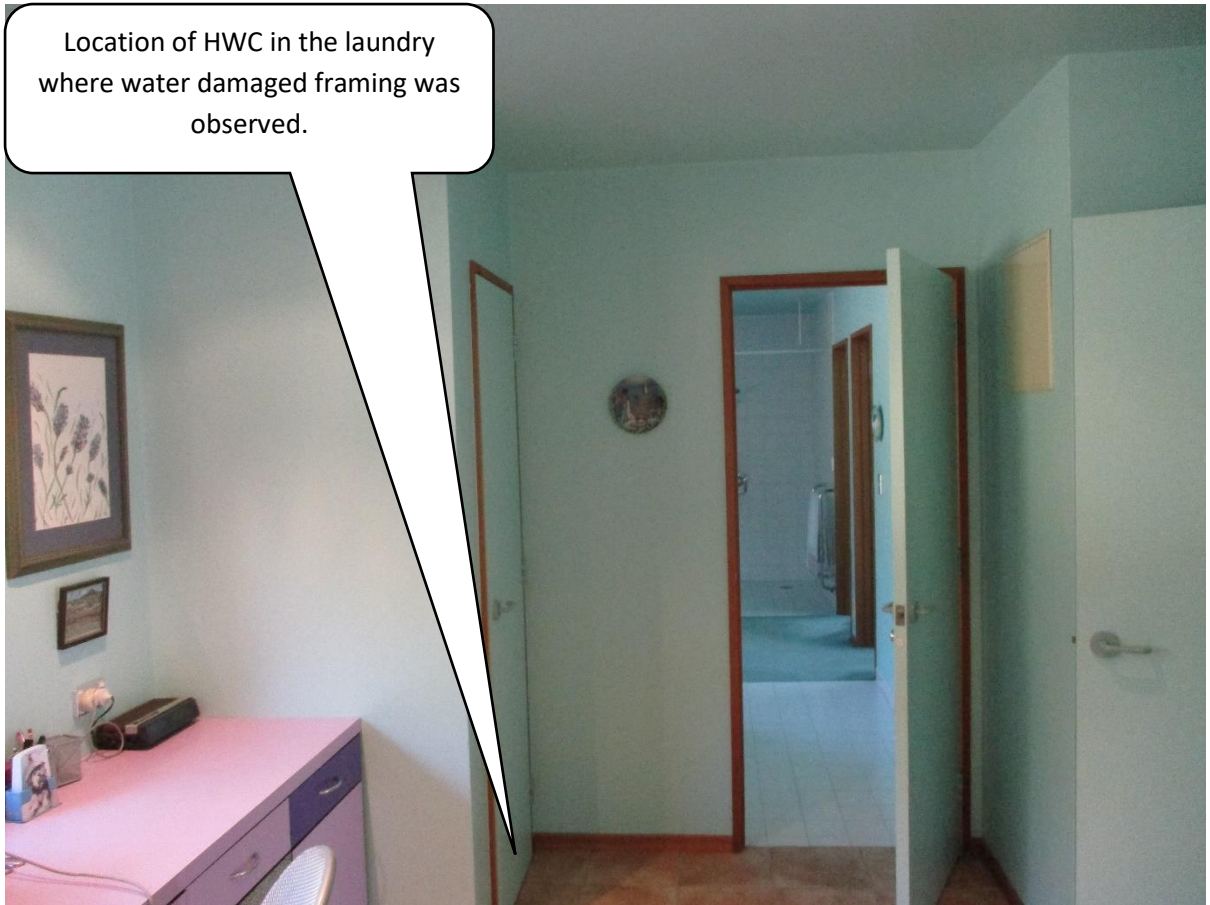
72.

Location of HWC in the laundry where water damaged framing was observed.

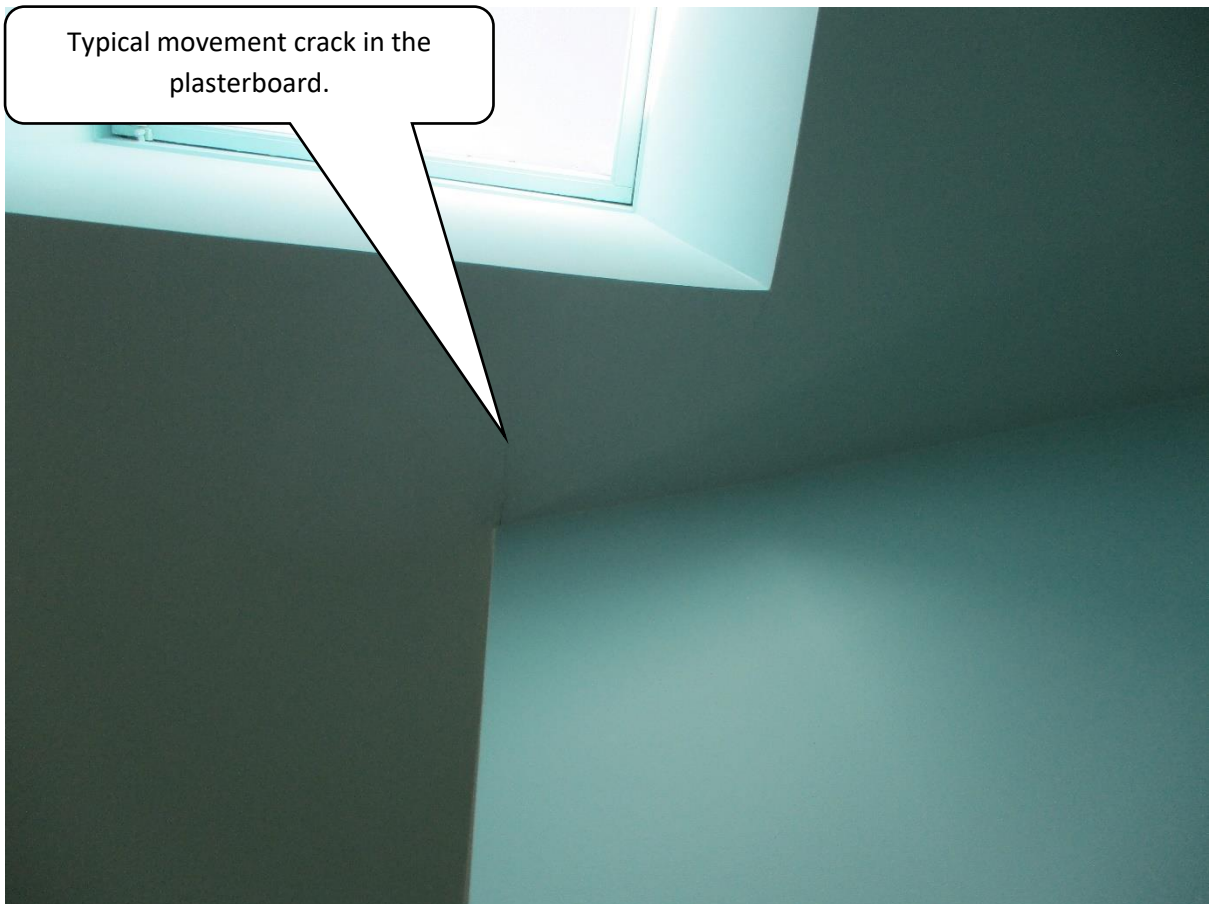
73.

Typical movement crack in the plasterboard.

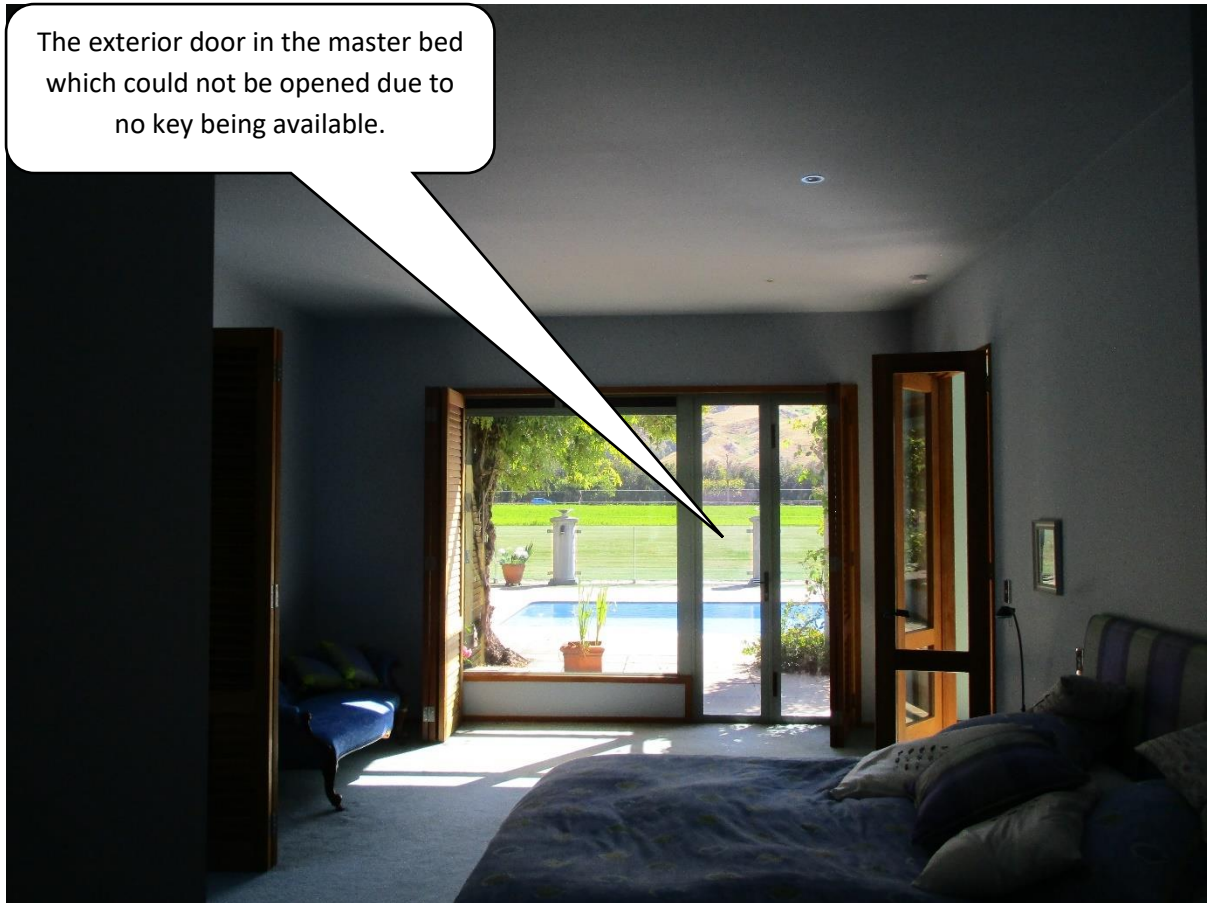
74.

The exterior door in the master bed which could not be opened due to no key being available.

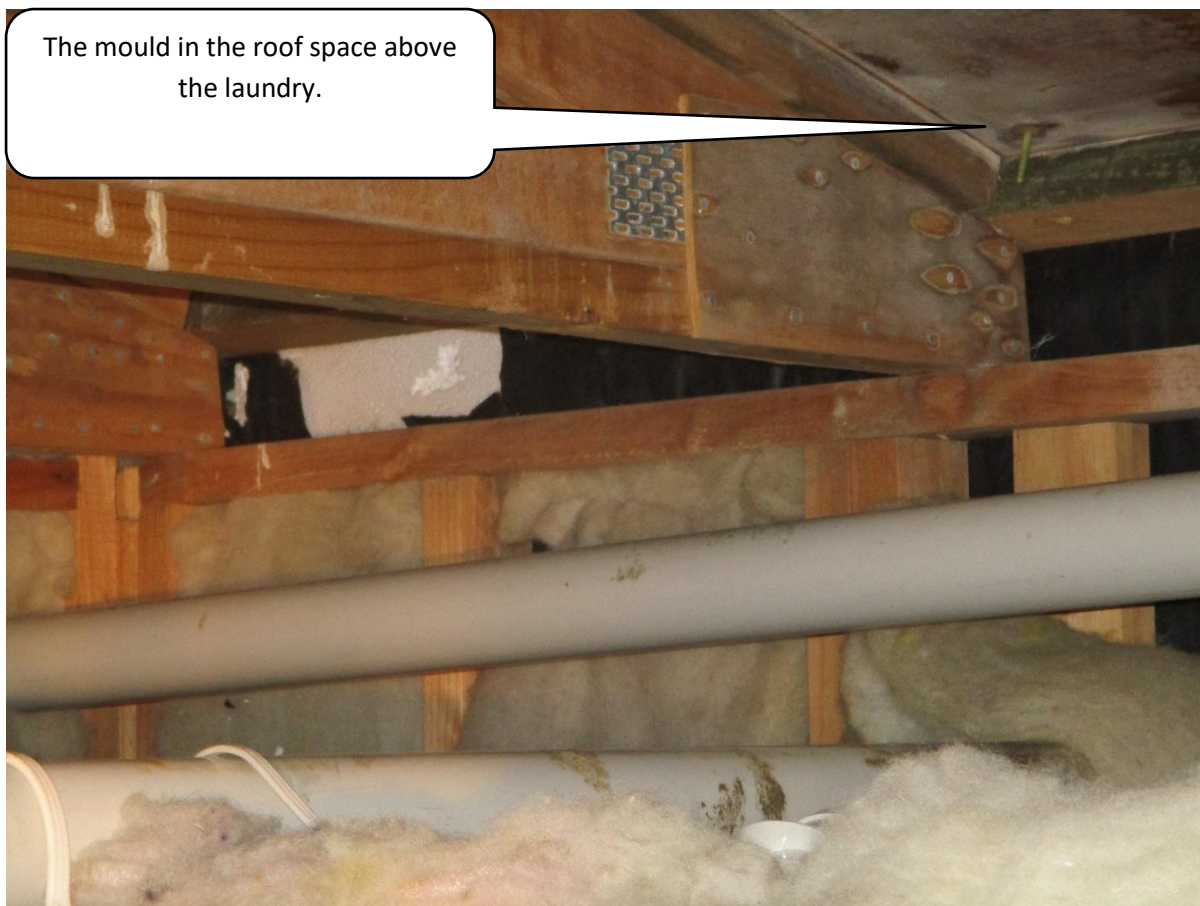
76.

- 12.18 The ceiling spaces above the entrance and bedroom 1 & 2 were viewed from the manholes only. Insulation was identified in the ceiling spaces viewed. It appeared to be a 50 mm thick white sheet. Refer to photo 75. Some mould was identified on the plywood sarking above the laundry. The cause of this was not determined. Refer to photos 76-77.

The mould in the roof space above the laundry.

1. Any plants touching the exterior cladding should be cut back.
2. The protective coating on the timber doors should be replaced.
3. All gutters should be cleaned.
4. All gutters should be checked for leaks and repairs made.
5. A suitably qualified engineer should be engaged to comment on the cracks in the floor and exterior walls of the garage.
6. Any stiff or hard to operate doors should be repaired.
7. All noisy extractor fans in the ensuite bathrooms and toilets should be replaced.
8. The grouting and seals in all showers should be checked and repaired where required.
9. The cause of the unidentified water stains in the office and living area should be investigated.
10. The cause of the mould in the roof space above the laundry should be investigated.

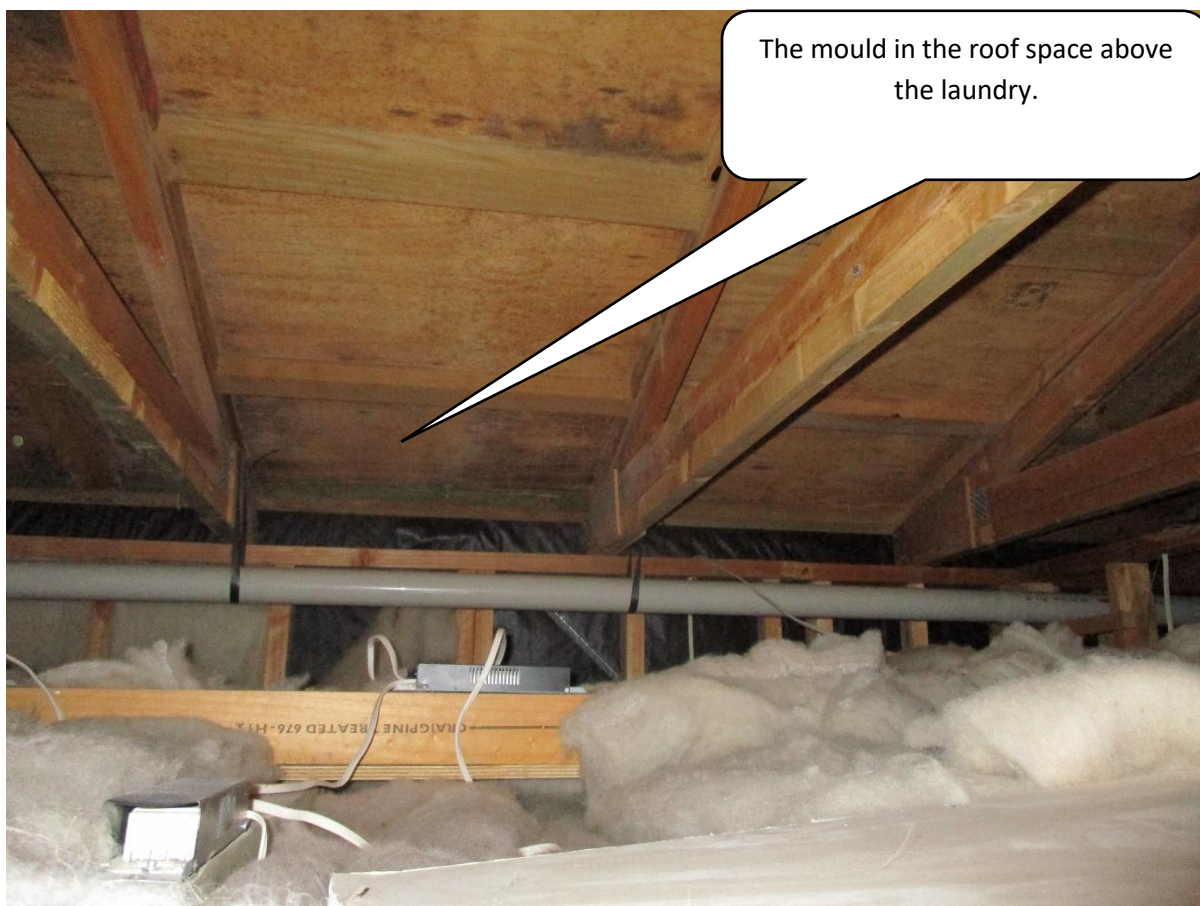
77.

The mould in the roof space above the laundry.
