## **BUILDING SURVEYORS REPORT**

### **Weathertightness Risk and Building Condition Assessment**

516 Frankton Ladies Mile Highway

26 March 2019

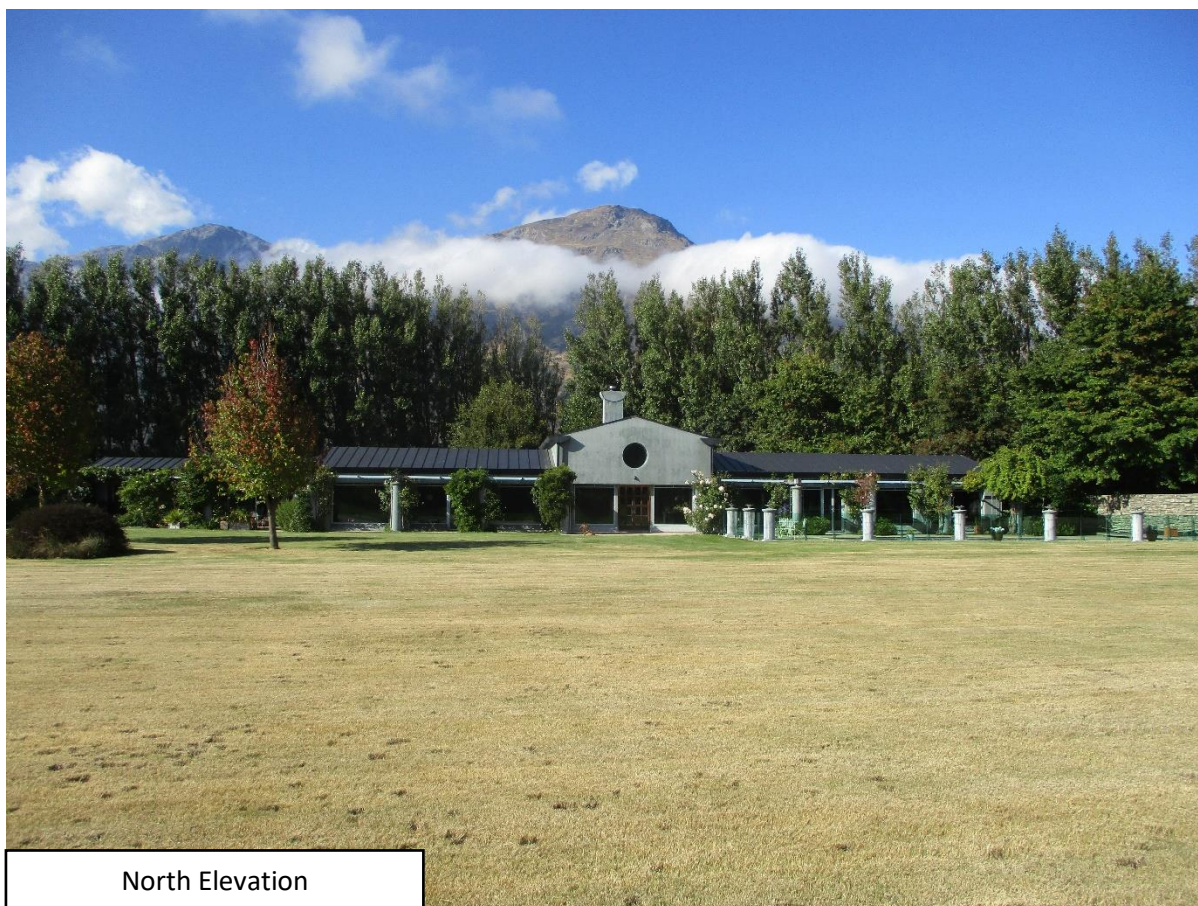
1.

North Elevation

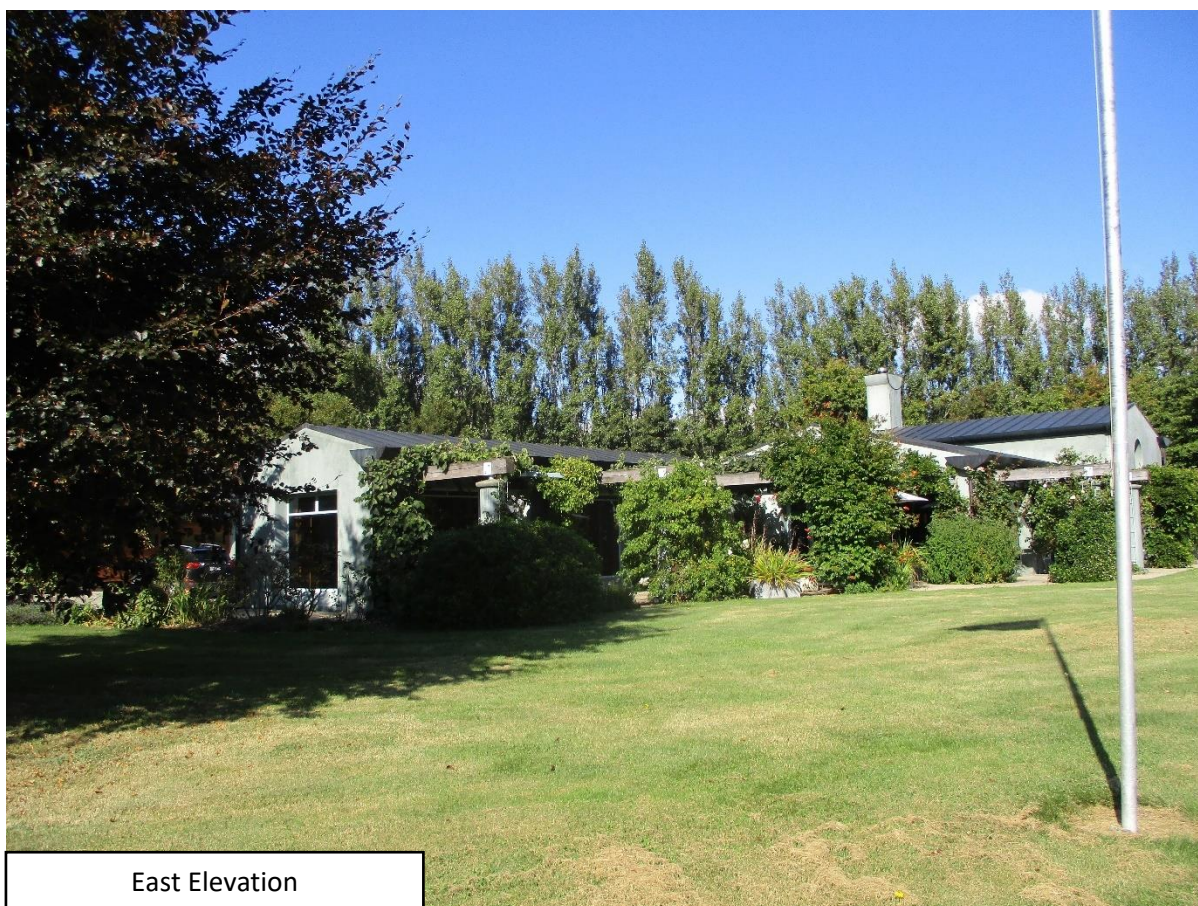
2.

East Elevation

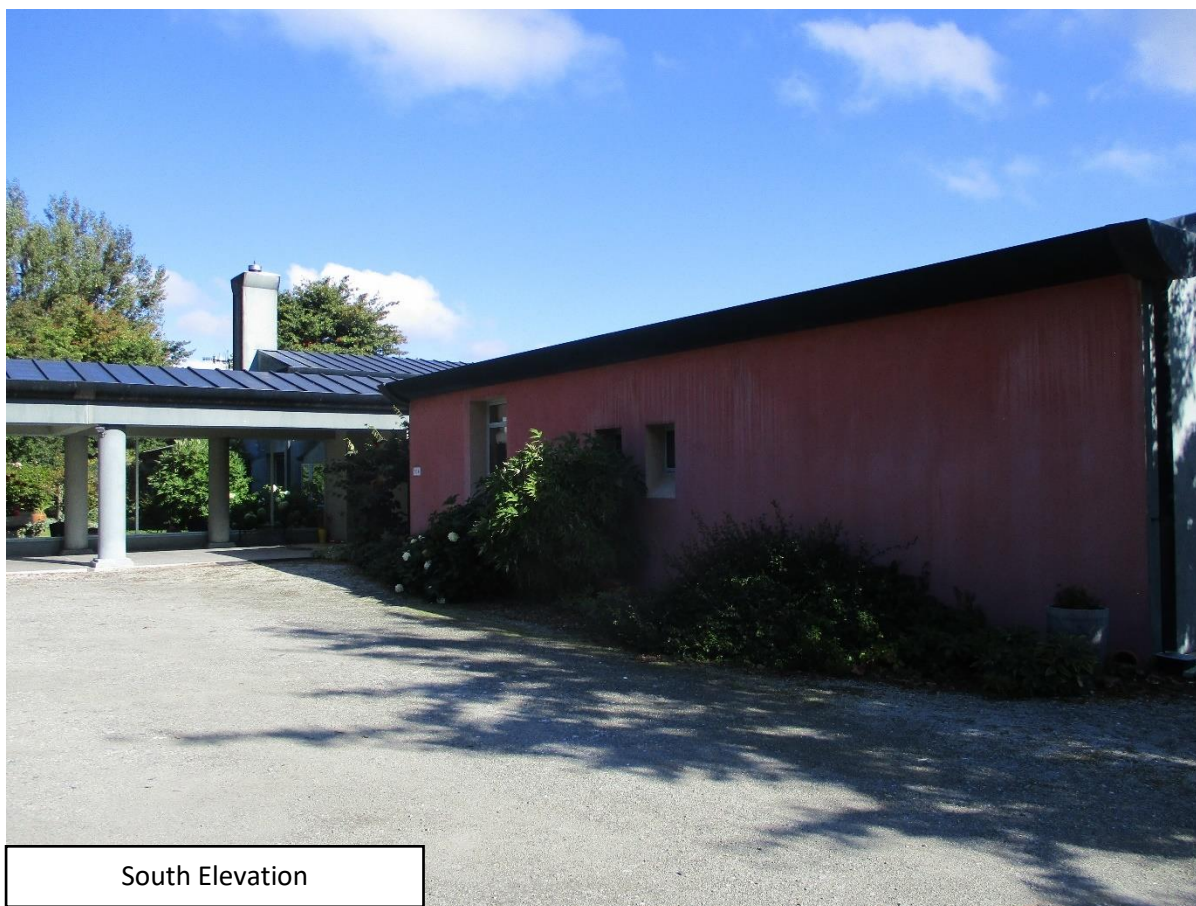
3.

South Elevation

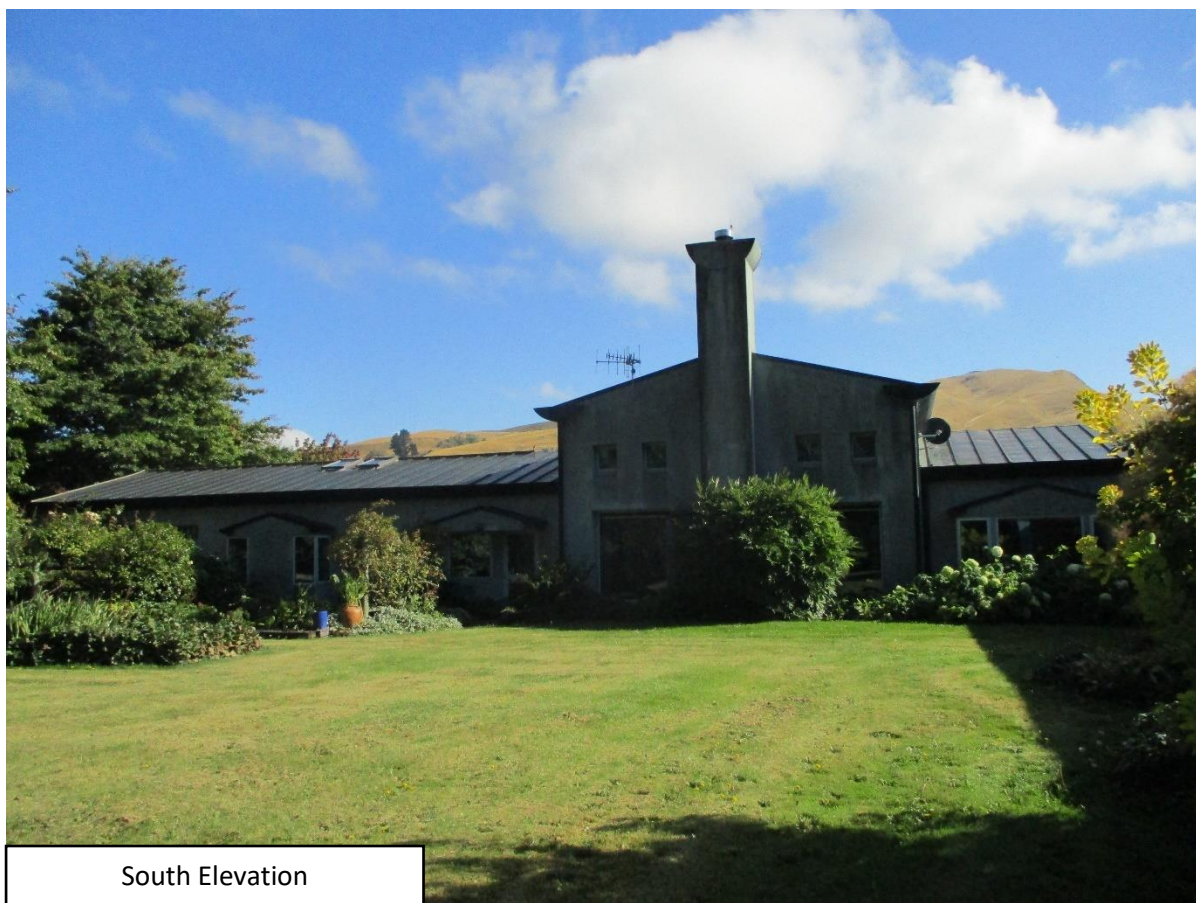
4.

South Elevation

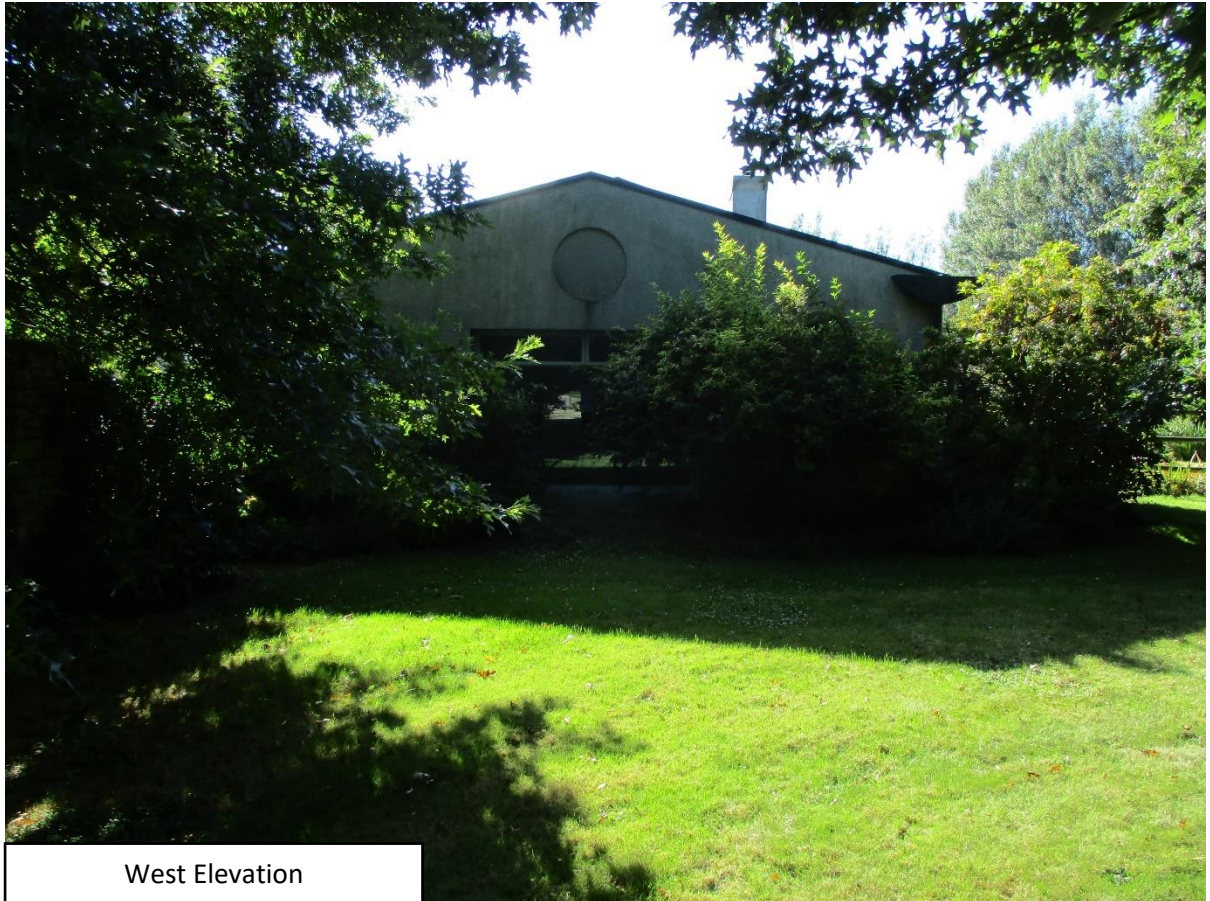
5.

West Elevation

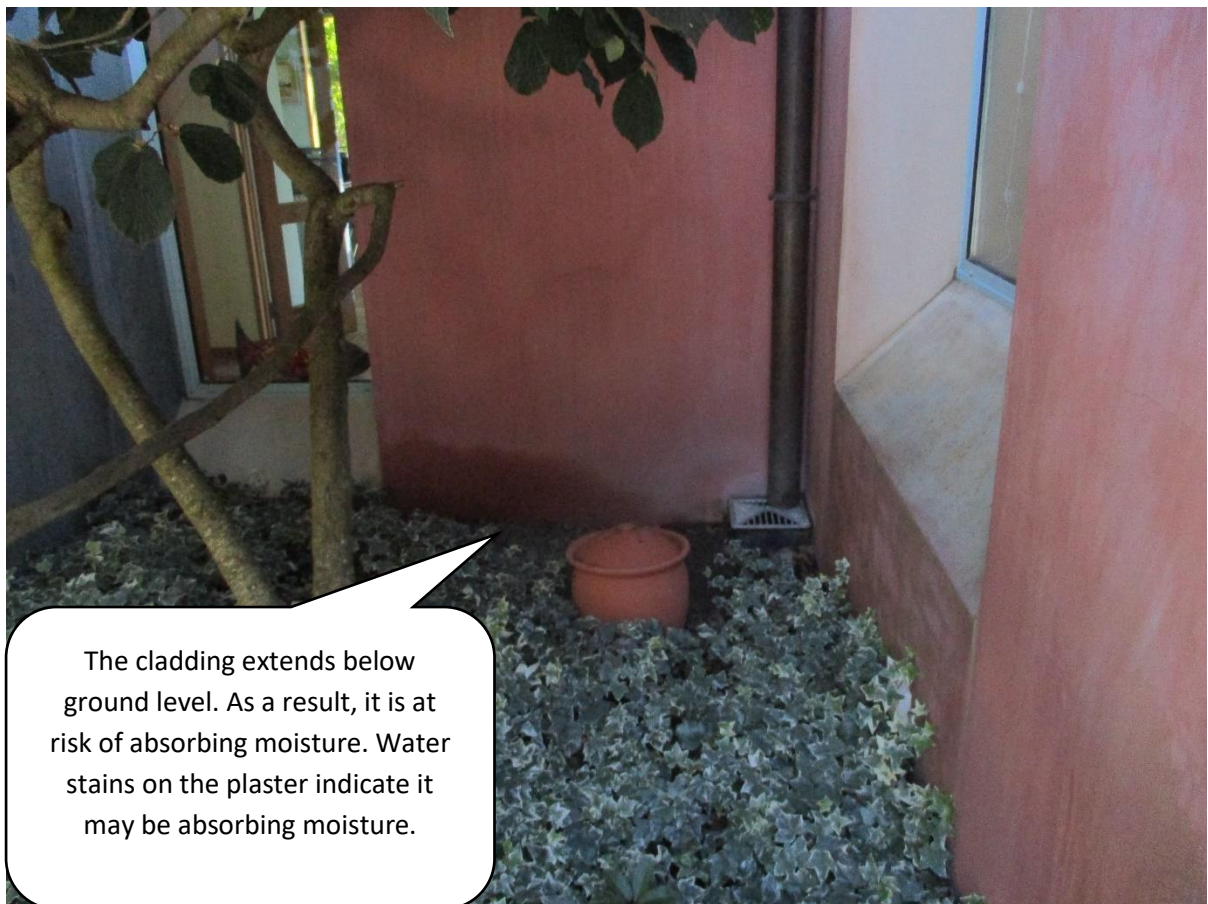
7.

There is less than recommended clearance between the base of the cladding and finished ground level on all elevations. The plaster cladding currently extends below finished ground level. No method to waterproof the plaster was observed. Uncoated plaster including bottom edges are very absorbent, and they will wick water from adjacent surfaces such as gardens and paths. Any accumulation of moisture in the cladding system could be absorbed into the wall framing behind where it could cause deterioration, damage or both. Refer to photos 6-9.

There is less than recommended clearance between the base of the cladding and finished ground level. The cladding extends below ground level. As a result, it is at risk of absorbing moisture.

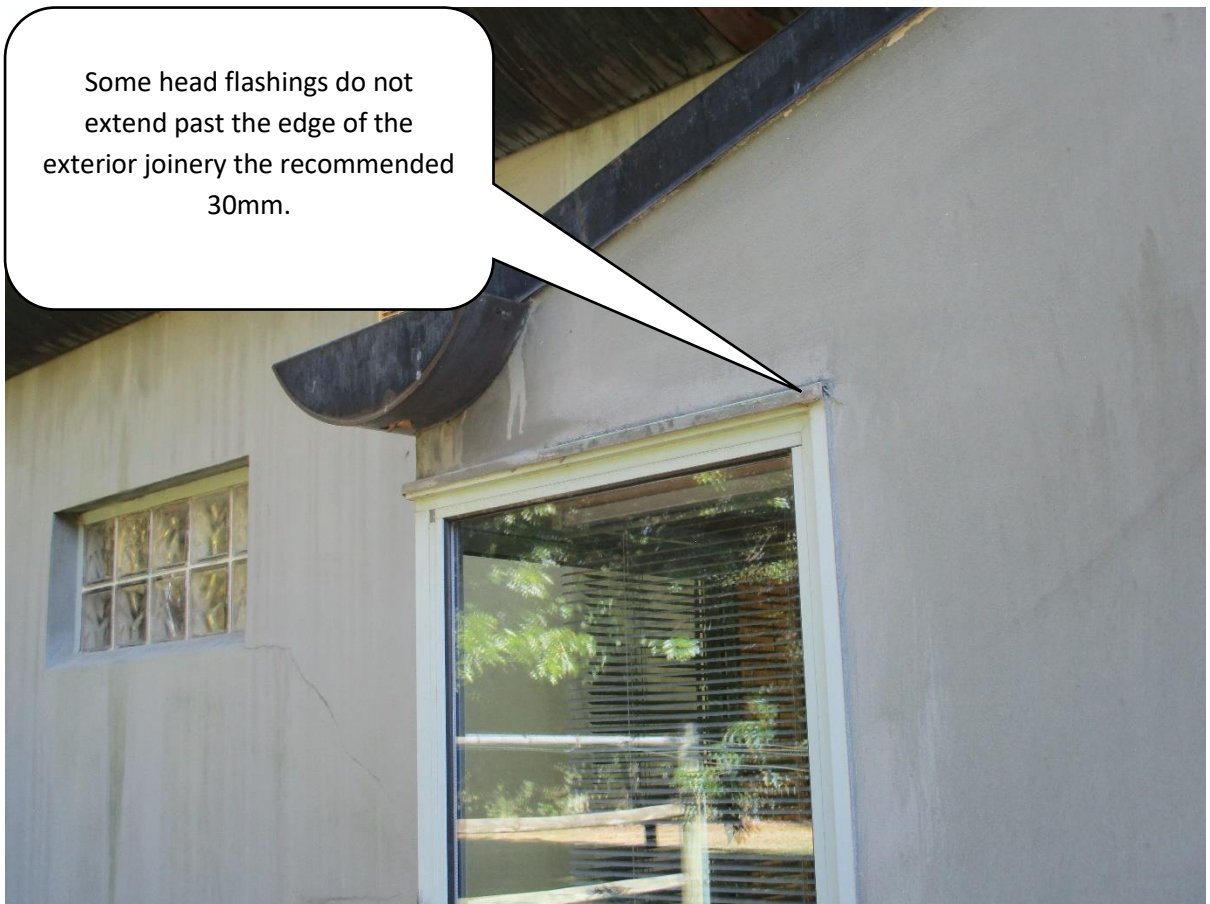
Some head flashings on the south elevation windows do not extend past the sides of the frames the recommended 30mm. This extension is to transfer water away from the junction of the joinery and the cladding. The risk here is water could ingress at this vulnerable junction. Any water ingress behind the cladding could accumulate where it could cause deterioration, damage or both. Investigation of the interior adjacent to these windows revealed no elevated moisture readings or visual evidence of deterioration or damage. Notwithstanding established building science suggest it is likely water has ingressed at these locations. Refer to photos 10-12.

Some head flashings do not extend past the edge of the exterior joinery the recommended 30mm.

As a result, water will not be transferred away from this vulnerable junction as recommended.

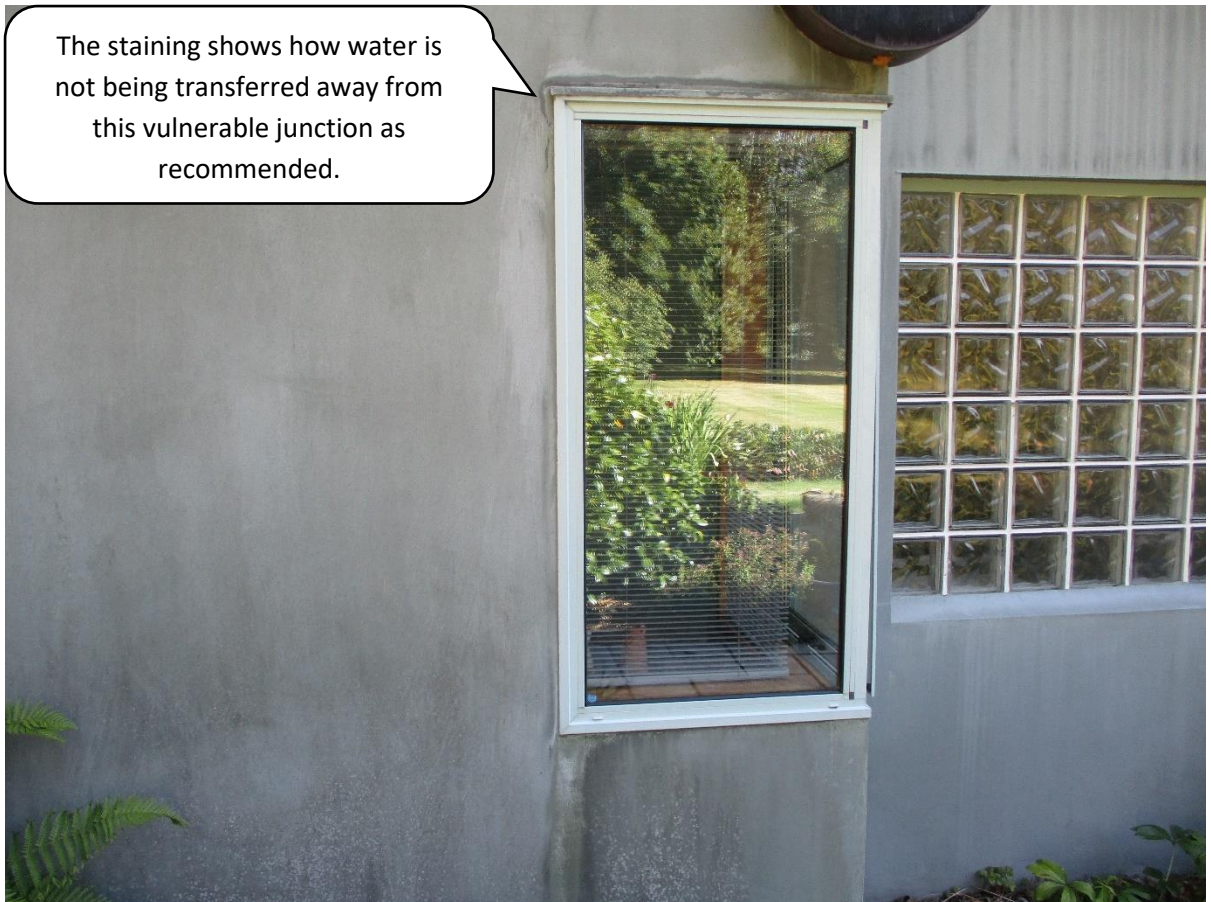
12.

The staining shows how water is not being transferred away from this vulnerable junction as recommended.

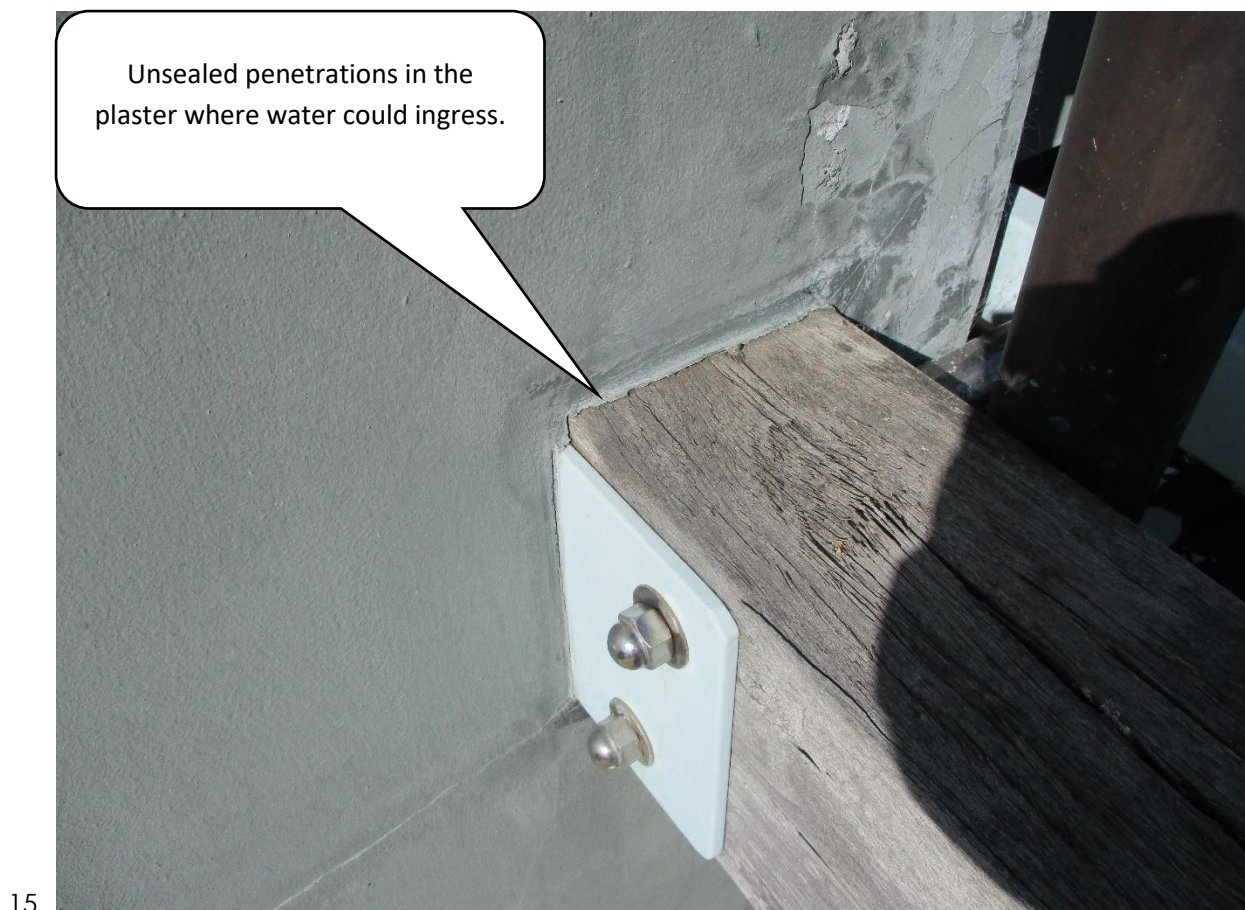
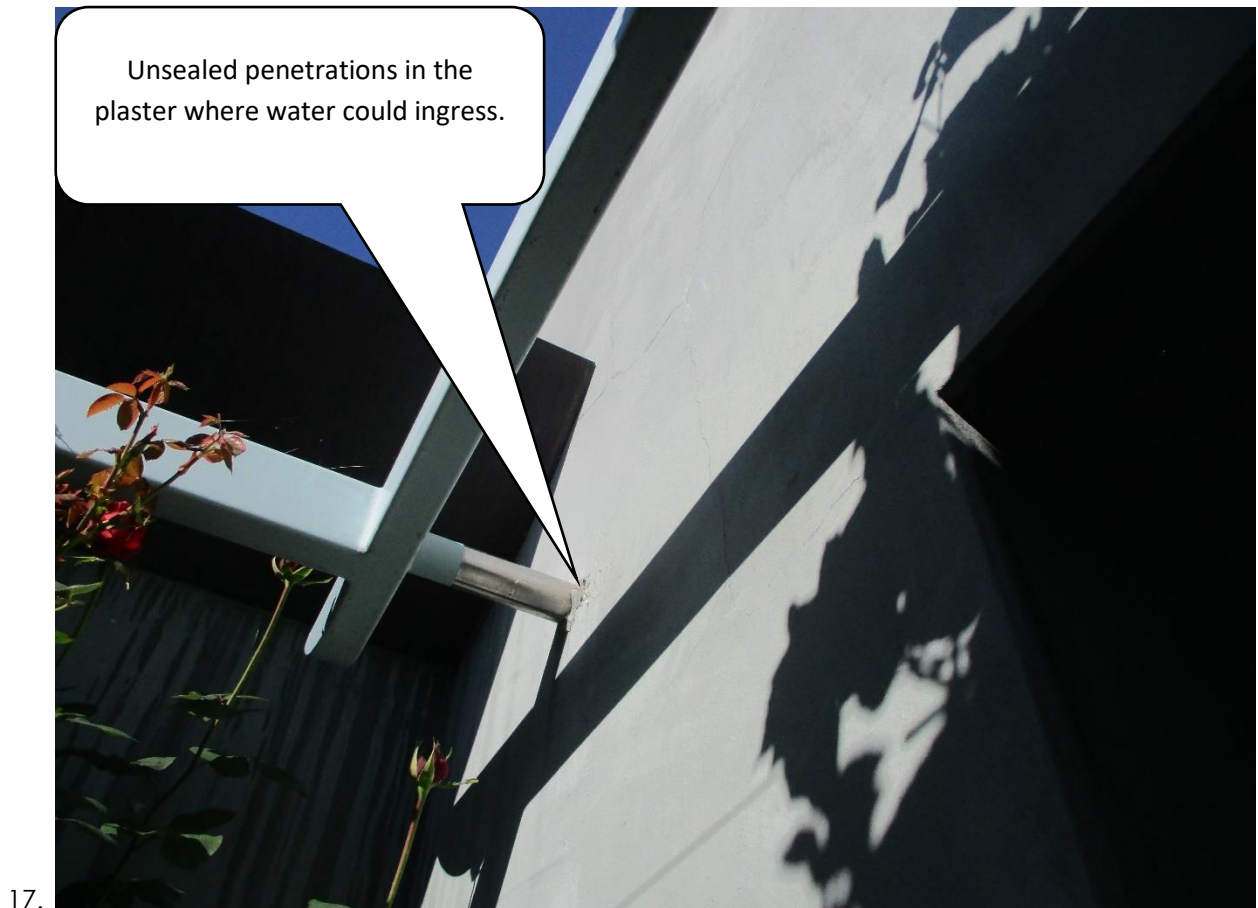
The condition of the paint and plaster system indicates it is due for urgent repair. Fading of the paint, hairline cracks and deterioration of the seals around penetrations were all identified. All of these defects could allow water past the face seal of the plaster cladding into the wall frame where it could accumulate and cause deterioration, damage or both. Refer to photos 19-28.

Example of deteriorated paint coatings. The paint is in poor condition indicating it is no longer providing a weatherproof coating to the plaster.

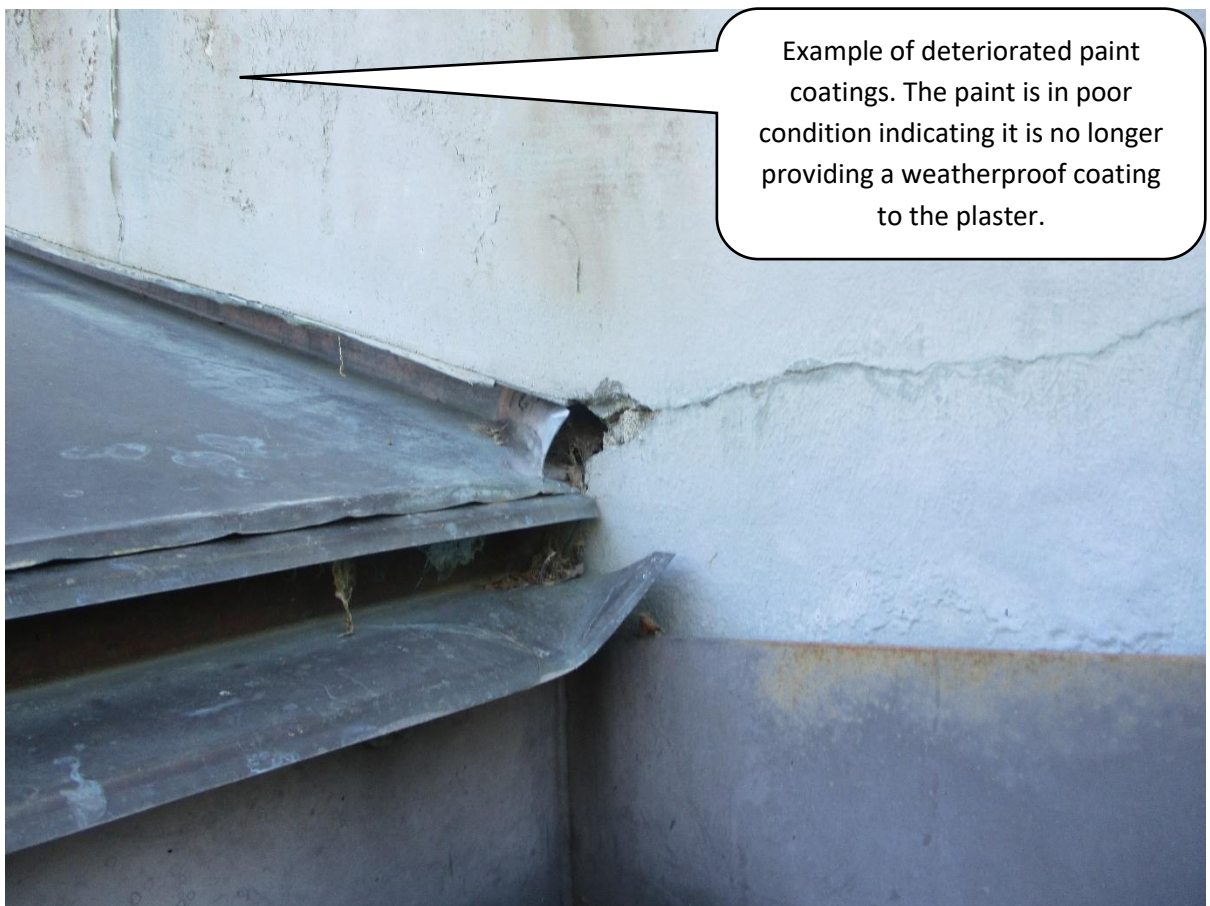
Short or shrunk back window rubber glazing beads were identified on some exterior joinery units. Age and exposure to sunlight will shrink the window rubber glazing beads, causing them to pull out at the corners or shrink back leaving gaps. Without correctly fitted window glazing beads it is possible for water to ingress the exterior joinery by gravity and capillary forces. It is also likely the sealant used during manufacture of the aluminum joinery is deteriorated and may be allowing some water through the joints of the frames. Refer to photo 29-30.

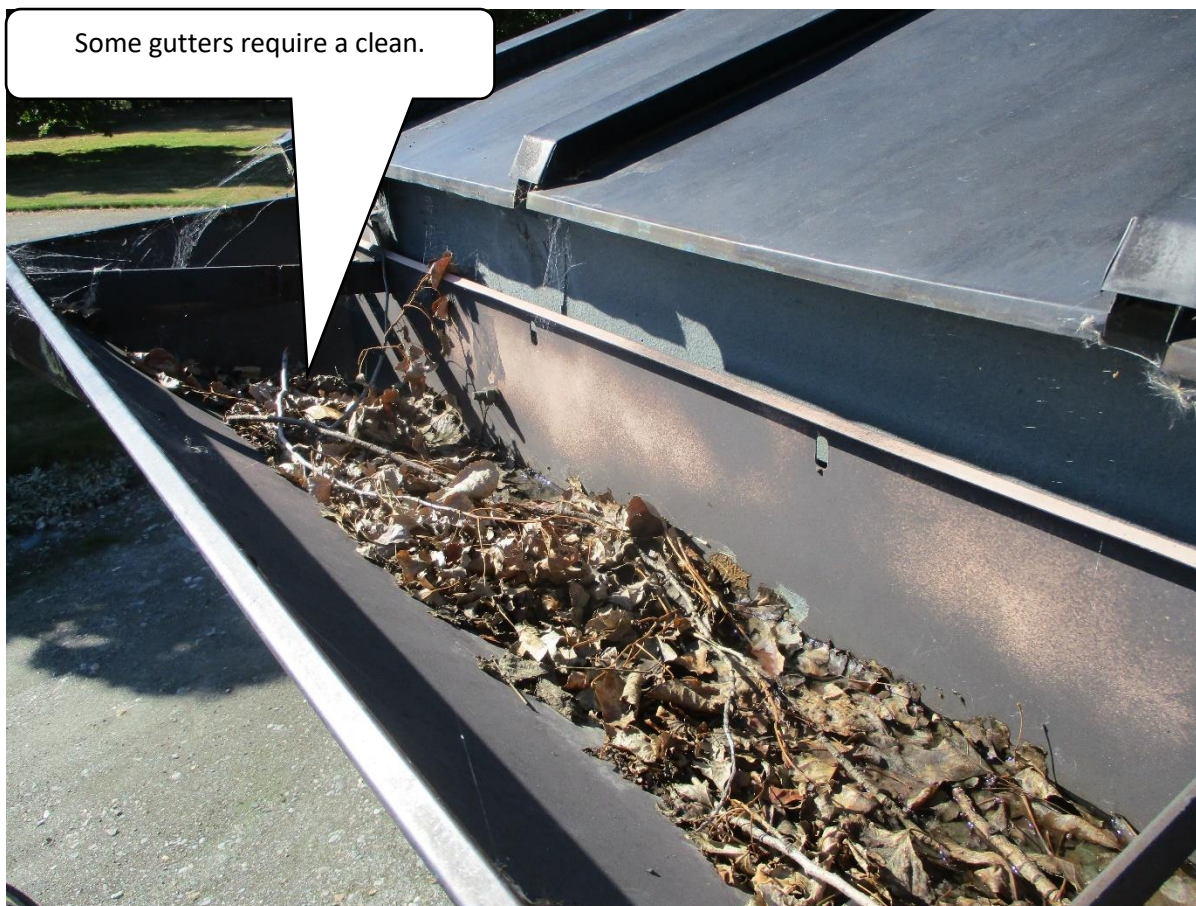
48.

Some gutters require a clean.
